HAWAII JUDICIAL SYSTEM MASTER PLAN

Volume III

Evaluation of Existing Judicial Facilities

Carter Goble Associates, Inc.
January 1989

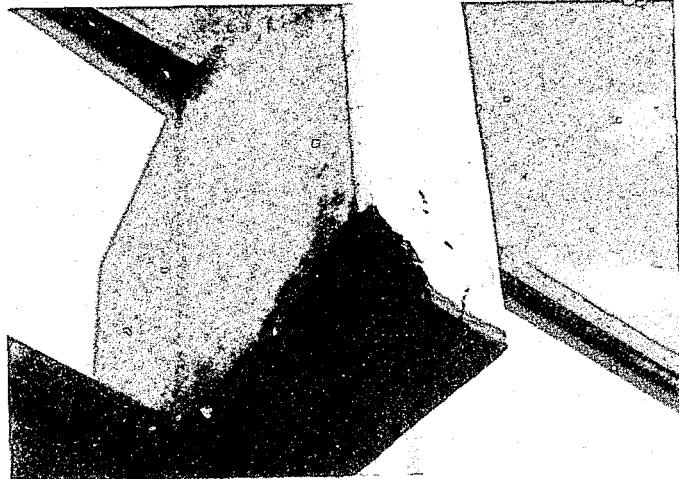
The concrete structure has suffered severely from settlement and spalling. The structural settlement has also caused masonry walls to crack and water to filter into interior spaces. The roof was repaired several years ago, but leakage is still occurring.

TYPICAL EXTERIOR CONCRETE BEAM SPALLING FROM WATER PENETRATION AND EROSION.

Given the high volume of usage at the Ewa District Courthouse, it is recommended that, based on a redistricting plan, this facility be retained with the understanding that a new Courthouse will reduce the demand on Ewa. However, repairs must be made to the concrete structure to prevent additional cracking as well as future erosion of concrete and reinforced steel. Furthermore, a new flexible membrane roofing should be installed. This will allow the membrane to move independently of the roof structure without causing further damage to the roofing system.

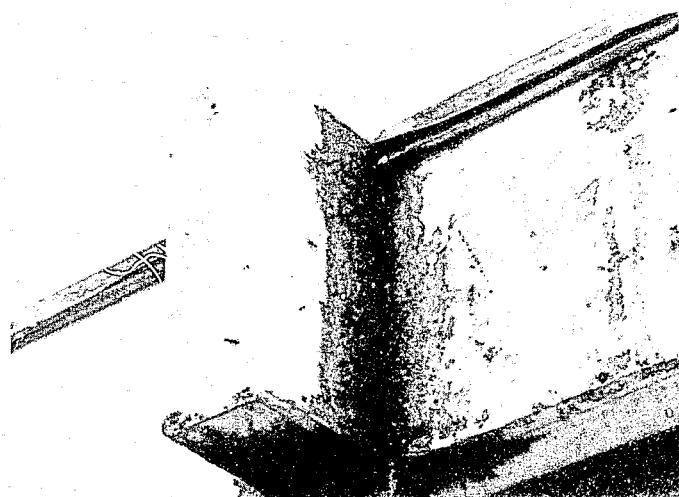
WATER DAMAGE AT CONCRETE ROOF BEAM.

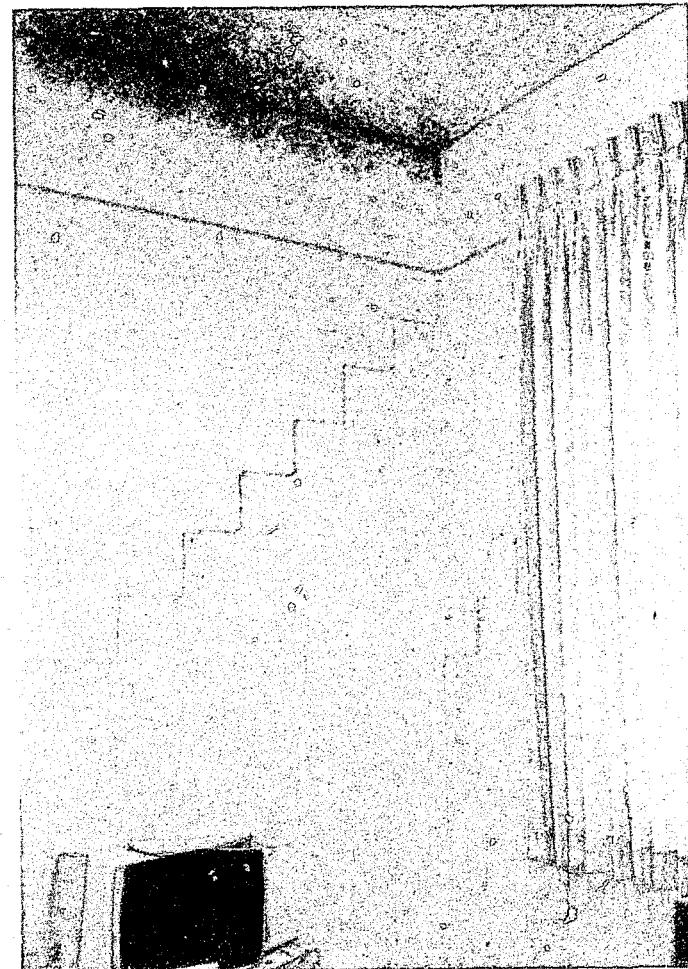
TYPICAL INTERIOR VIEW SHOWING MASONRY CRACKS CAUSED BY SETTLING.

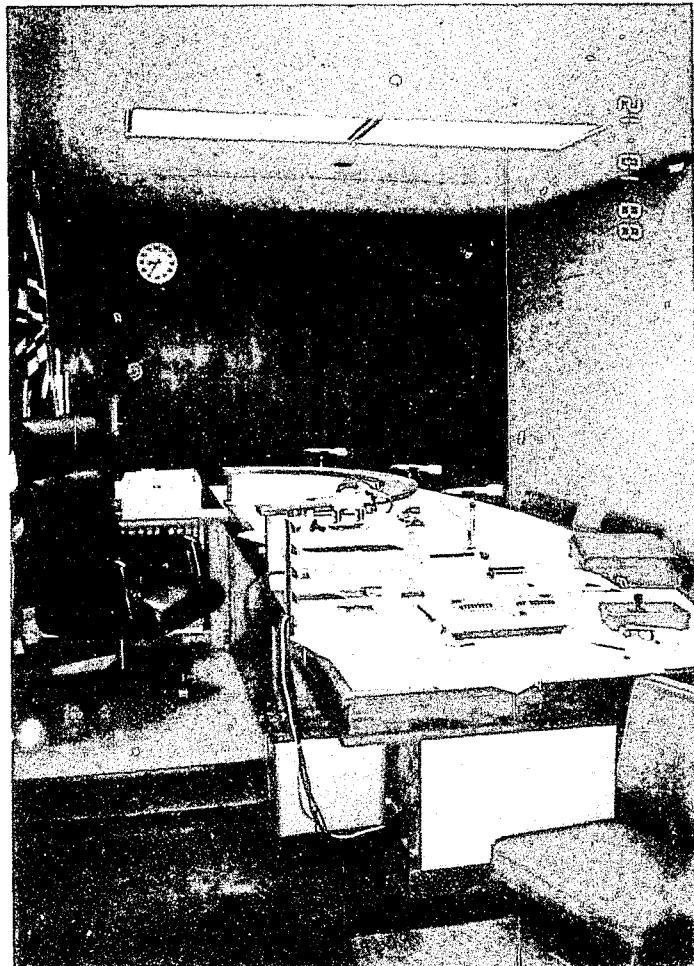
FAMILY COURTROOM SHOWING TIGHT SPACE WHERE PARTIES SIT
NEXT TO ONE ANOTHER IN FRONT OF THE HEARING JUDGE.

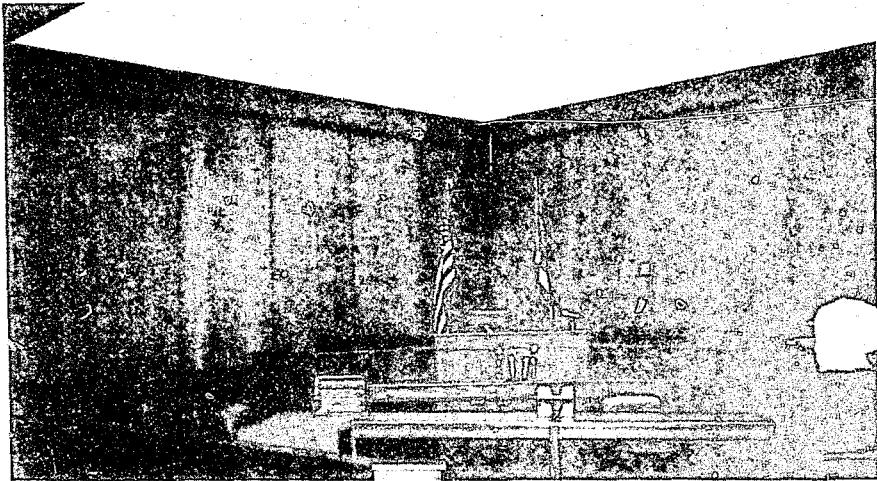
VIEW OF TYPICAL LARGE COURTROOM. COUNTER IN FRONT OF JUDGE'S BENCH MAKES IT DIFFICULT TO CONVERSE WITH JUDGE.

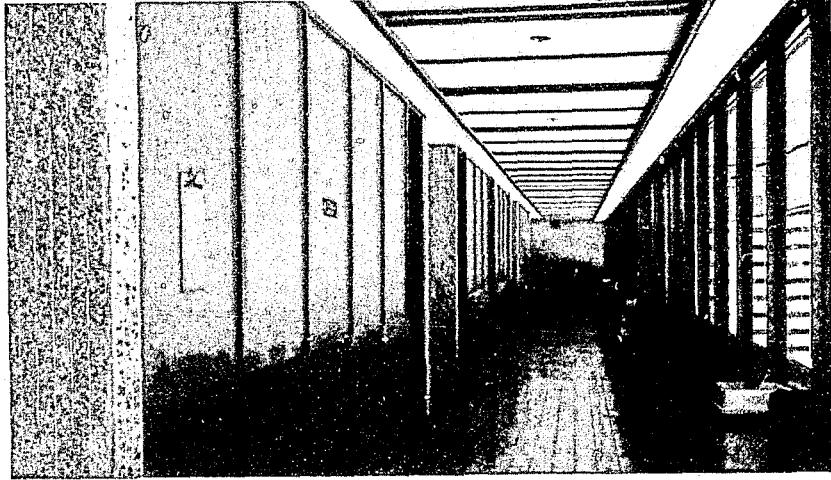
VIEW OF CORRIDOR IN FRONT OF THE COURTROOMS. NARROW WIDTH CAUSES CONGESTION WHEN COURT IS IN RECESS.

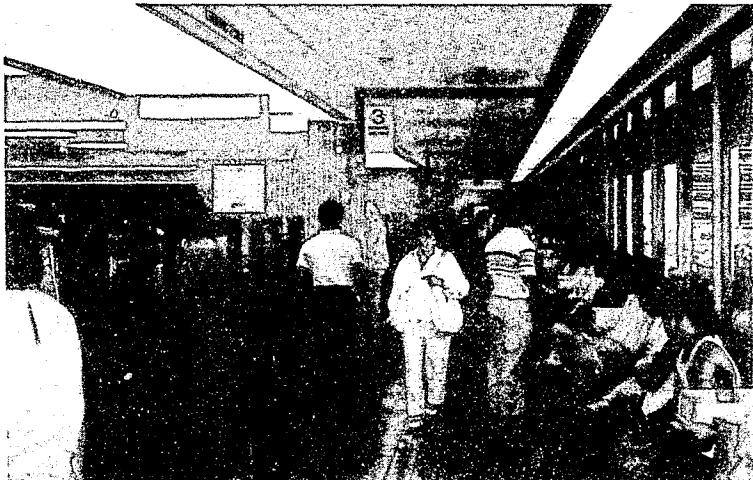
VIEW OF CLERK'S COUNTER, WITH COMBINATION OF PUBLIC WAITING, QUEUING AND CIRCULATION.

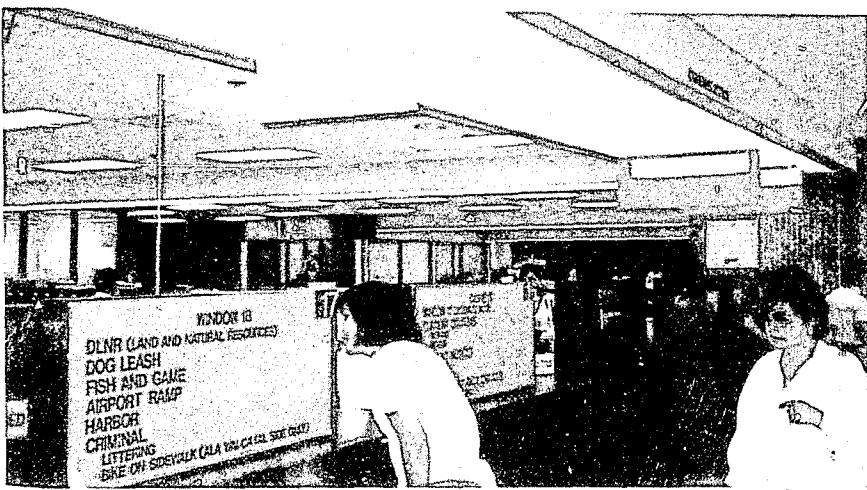
VIEW OF INDIVIDUAL CUBICLE AT CLERK'S COUNTER. LACK OF DIRECTORY INFORMING WHAT COUNTER TO USE CAUSES CONFUSION AND CONGESTION.

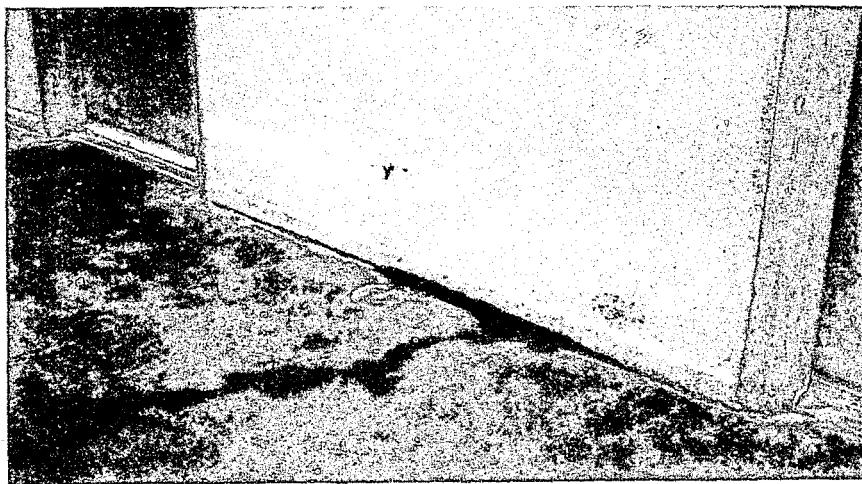
PLUMBING LEAK IN BOYS' HOUSING AREA.

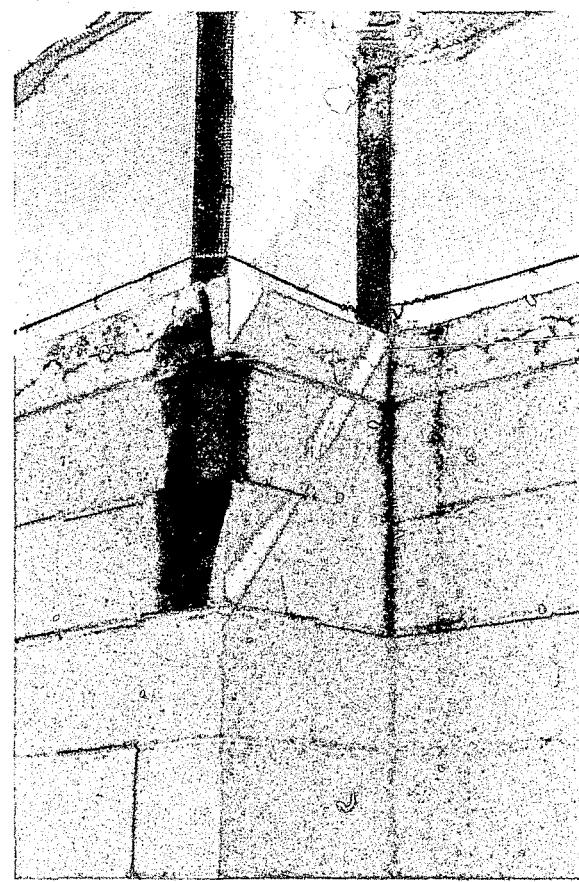
The facility is rated as physically inadequate. There are significant masonry cracks in the exterior wall. There is evidence of extensive termite damage throughout the facility. There has been a problem with water infiltration in the plaster ceiling of the men's lanai and in the exterior wall behind a toilet room. There is no hot water for bathing and a number of the toilet/shower areas are in poor and unsanitary condition. The kitchen has flooded (up to 3-4 inches) during heavy rains. Many of the interior finishes show signs of deterioration. There is inadequate ventilation in some of the housing units and no sprinkler systems for fire protection. Finally, an asbestos product ceiling is used in the classrooms.

CRUMBLING MASONRY OF OUTER WALL.

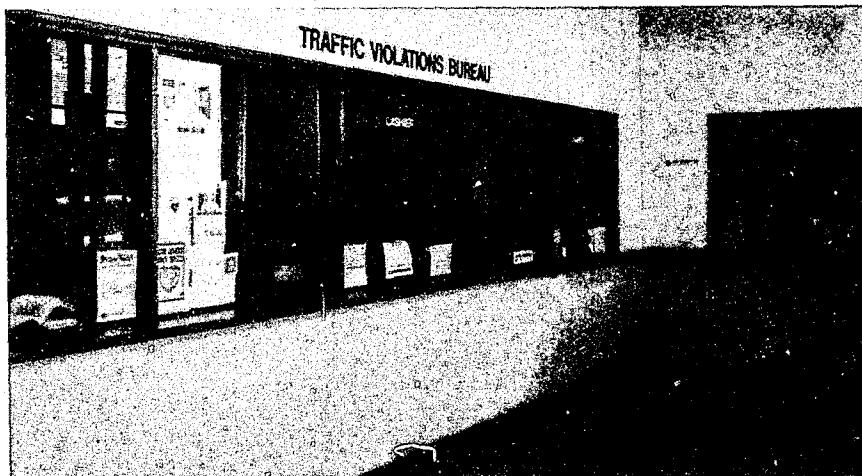
PUBLIC WAITING AREA AT CLERK'S COUNTER.

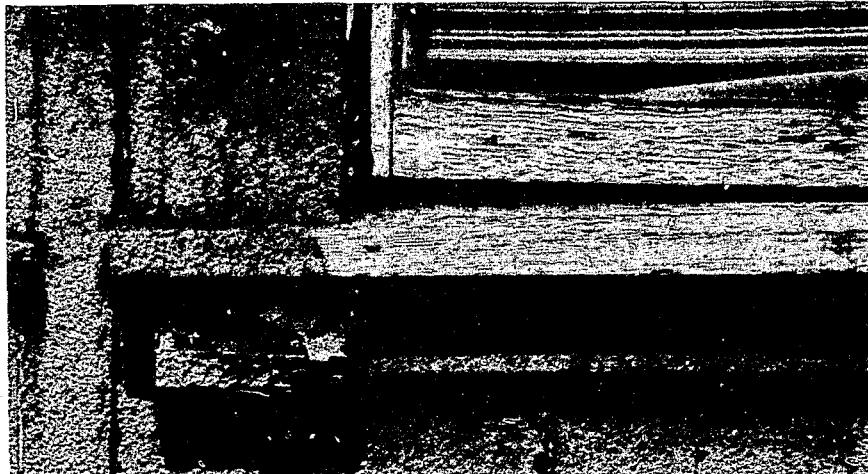
VIEW OF TERMITE AND WATER DAMAGE TO WOOD WINDOW SILL AND PLASTER COATING.

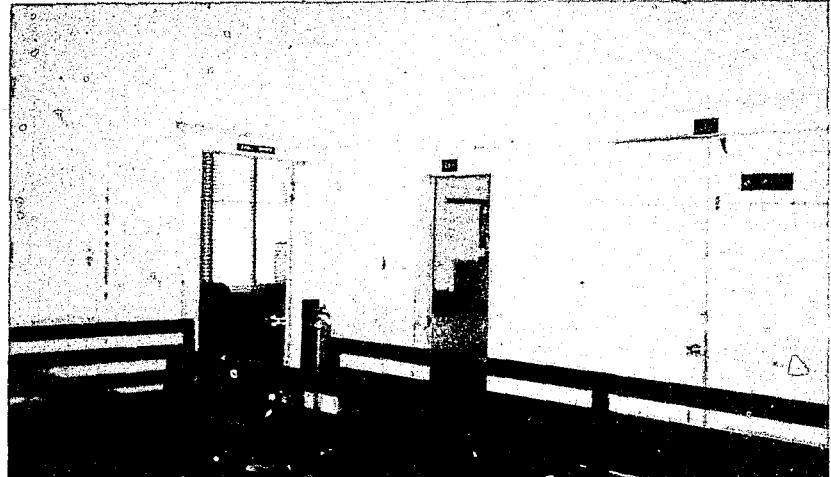
VIEW OF REAR OF COURTROOM. SMALL SIZE MAKES IT AN OPERATIONALLY INEFFICIENT COURTROOM.

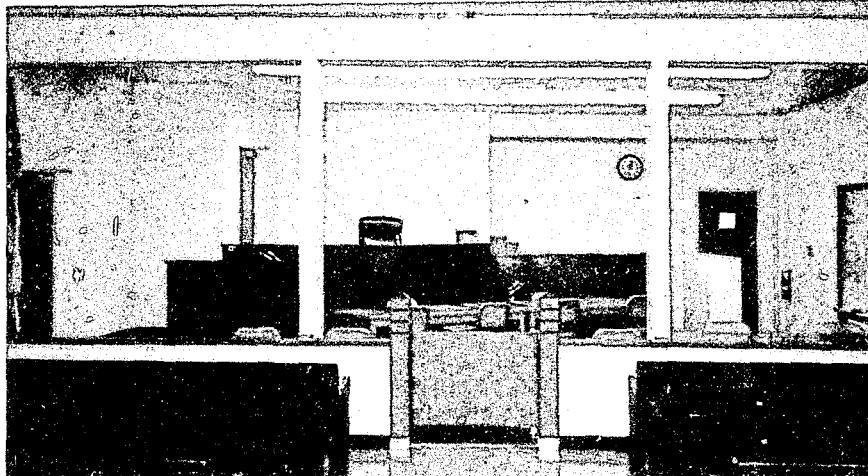
VIEW OF COURTROOM. COLUMNS OBSCURE IMPORTANT SIGHTLINES FROM THE JUDGE'S BENCH.

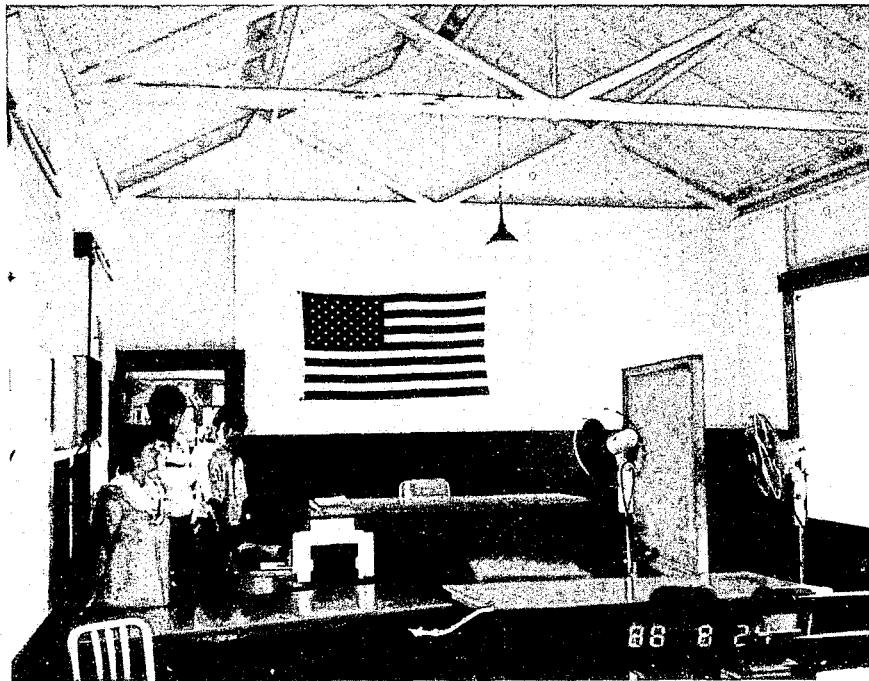
INTERIOR VIEW OF COURTROOM SHOWING A METAL DESK AS THE JUDGE'S BENCH, LACK OF A WITNESS STAND, ATTORNEY'S TABLE TOO CLOSE TO ONE ANOTHER.

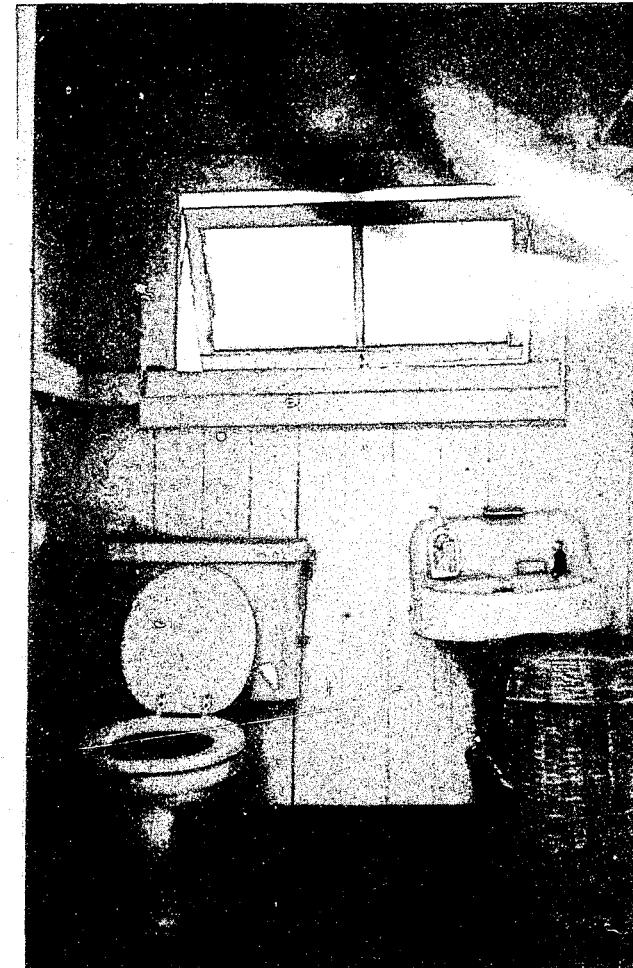
DETERIORATED CONDITION OF RESTROOM AT THE REAR OF THE COURTHOUSE.

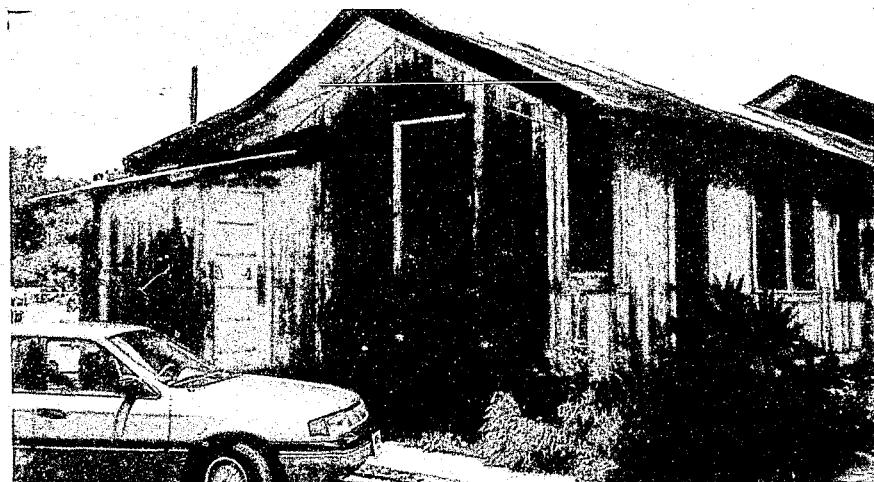
EXTERIOR VIEW SHOWING RESTROOM AT THE REAR WHICH IS ONLY ACCESSIBLE FROM THE OUTSIDE.

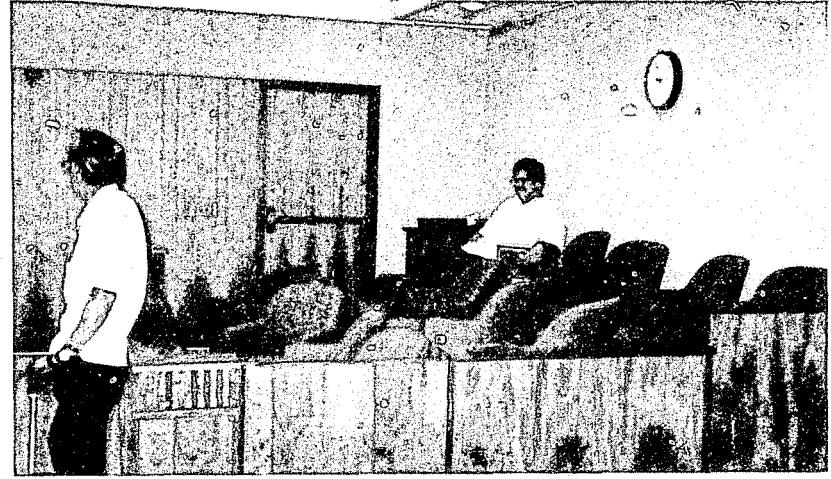
THREE TIER JURY BOX REDUCES THE WORKABLE AREA IN THE LITIGATION AREA.

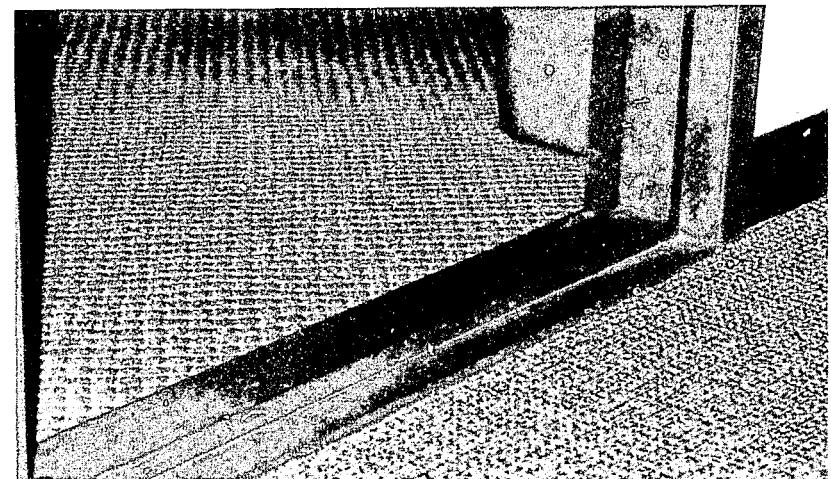
SOUND GASKETS AT THE DOOR SILLS LEADING INTO THE COURTROOMS POSES A TRIPPING HAZARD.

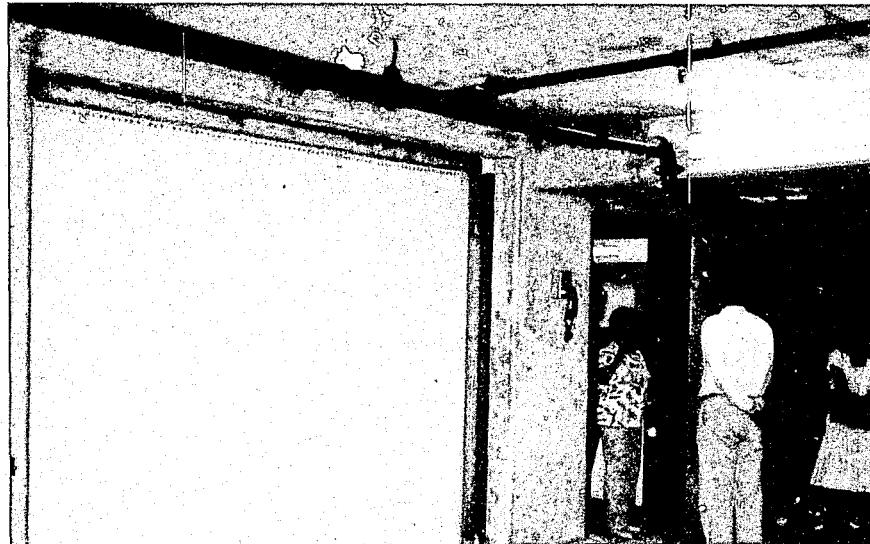
VIEW OF ENTRY TO SALLYPORT. LOW OVERHEAD SPRINKLER PIPES PRECLUDE POLICE VANS FROM DELIVERING DETAINES TO THE SALLYPORT.

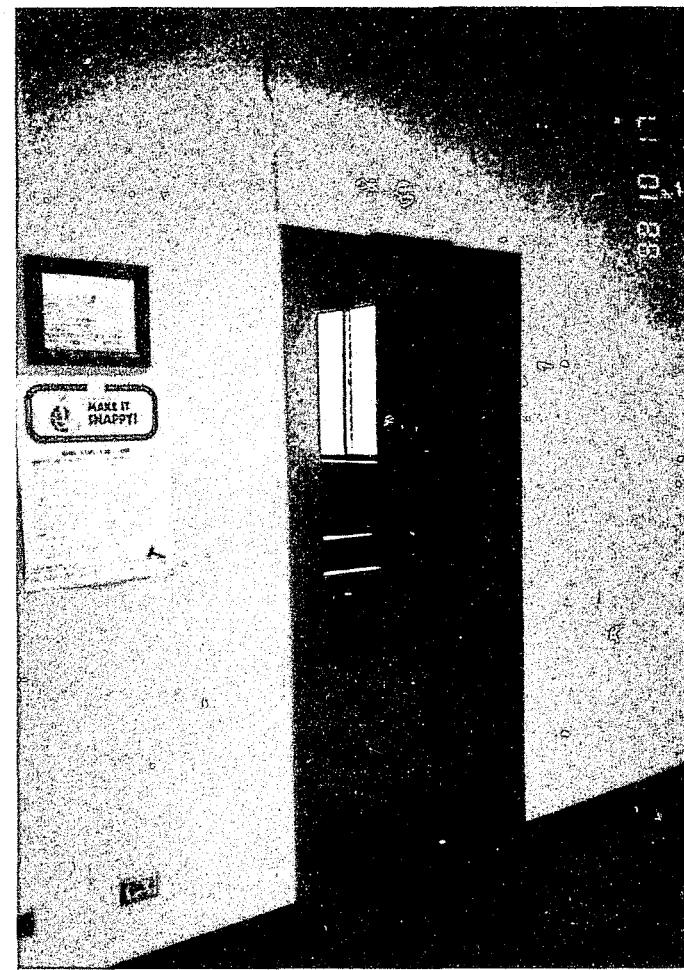
TYPICAL DRYWALL CRACKS AT DOOR HEAD PARALLEL TO JAMB,
ASSUMED TO BE CAUSED BY MINOR EARTHQUAKES.

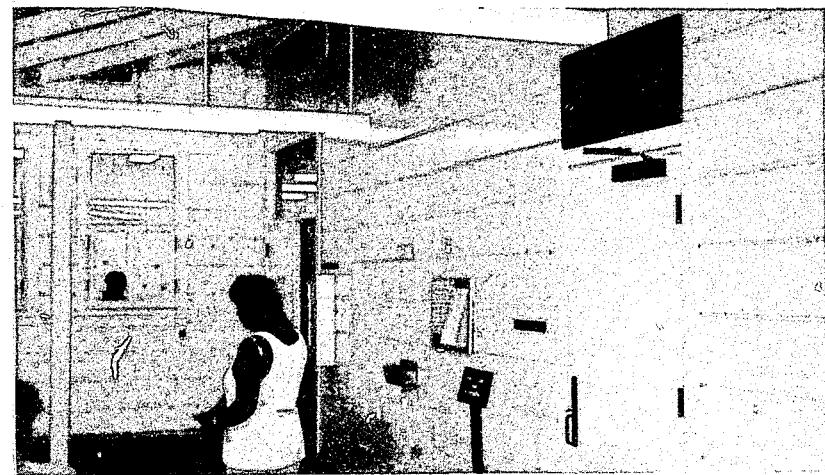
EXTERIOR WAITING FOR THE DISTRICT COURTROOM WHICH CREATES A NOISY CONDITION FOR THE COURTROOM AND A UNATTRACTIVE SPACE.

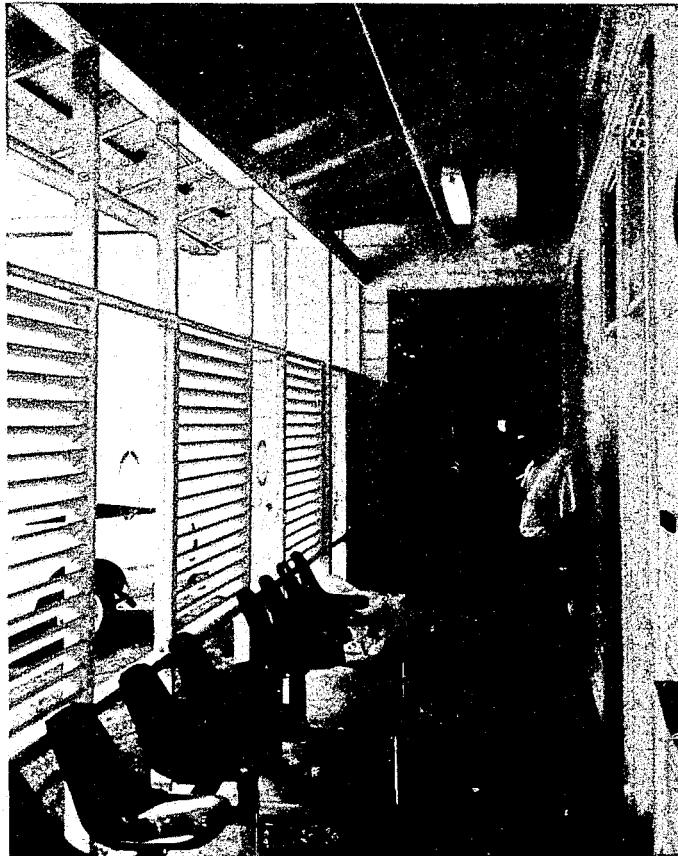
EXTERIOR WAITING FOR CIRCUIT COURTROOM. DOORS TO RIGHT LEAD DIRECTLY INTO THE COURTROOM CREATING A NOISY CONDITION.

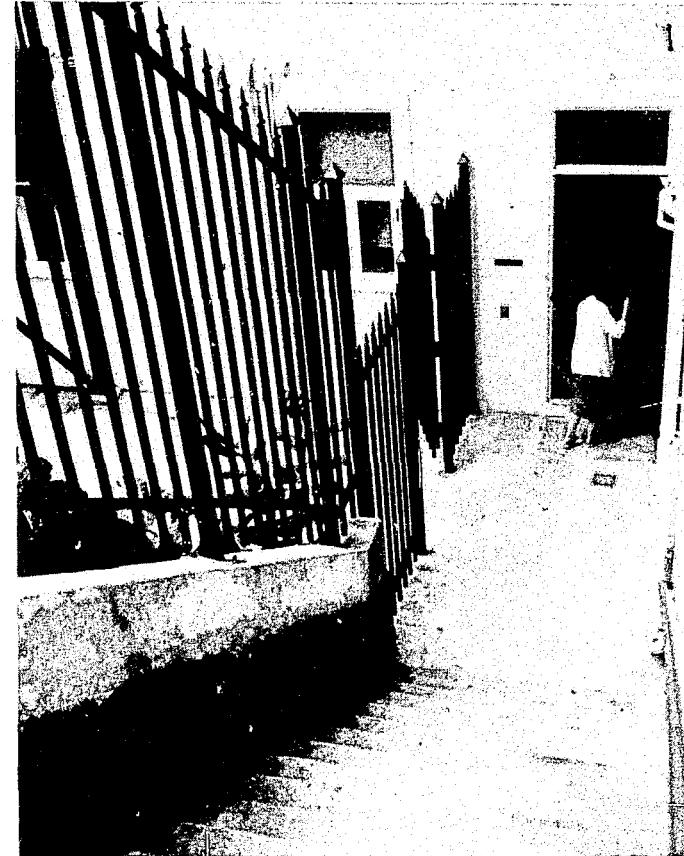
VIEW OF STEPS LEADING DOWN TO THE HOLDING CELLS, A DIFFICULT PROCESS FOR PRISONERS IN SHACKLES.

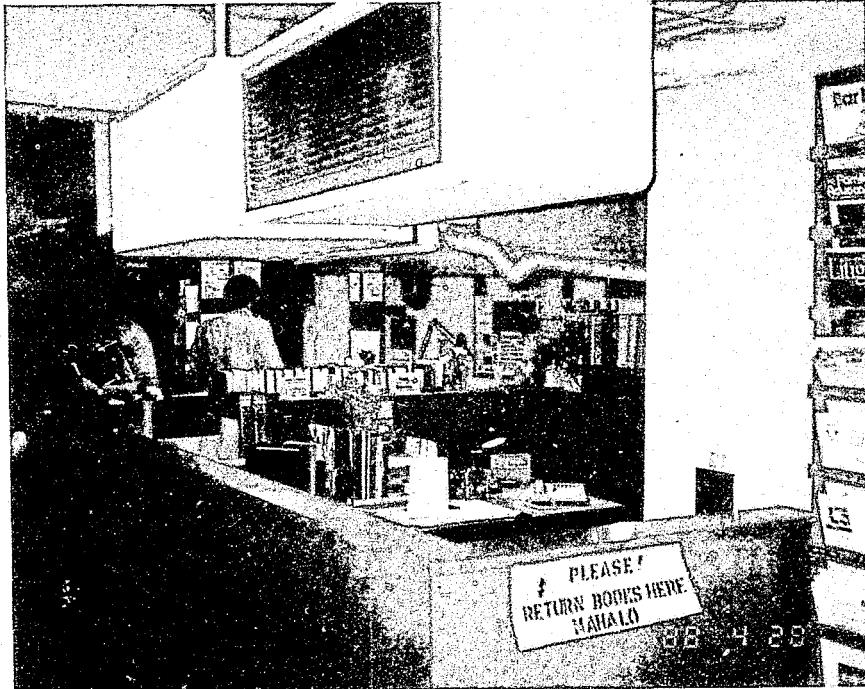
VIEW OF LAW LIBRARY IN BASEMENT SHOWING OVERHEAD AIR HANDLING UNIT REDUCING CLEARANCE AT THE COUNTER.

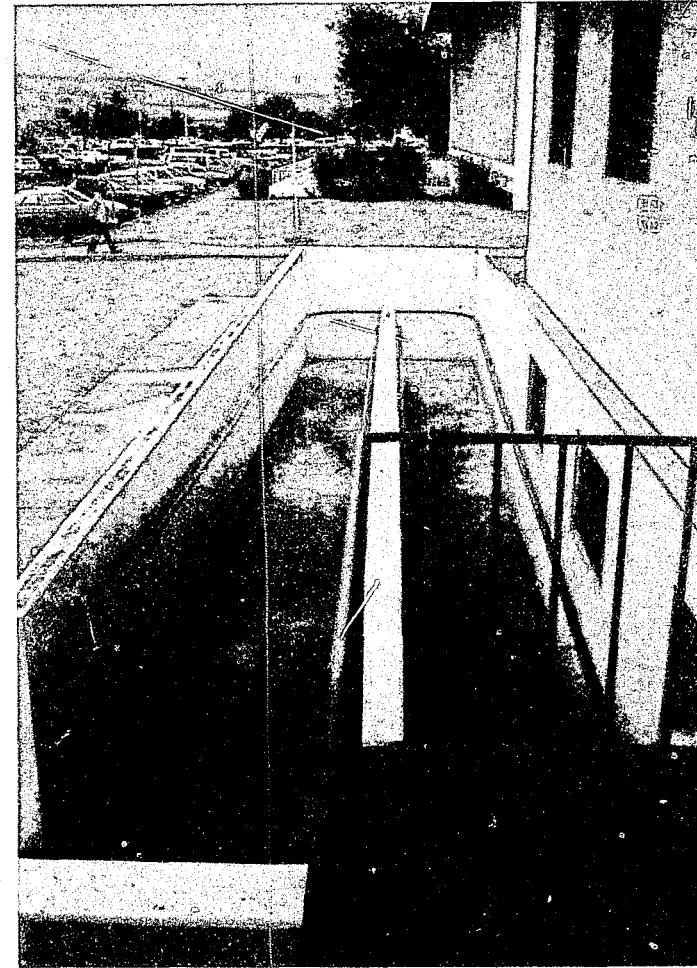
HANDICAPPED RAMP LEADING TO BASEMENT THAT HAS CAUSED FLOODING DUE TO UNDERSIZED DRAINS AT THE INTERMEDIATE AND BOTTOM LANDING.
