BUILDING SCIENCE SERIES 105

Retrofitting an Existing Wood-Frame Residence for Energy Conservation— An Experimental Study

D. M. Burch
C. M. Hunt

Issued July 1978

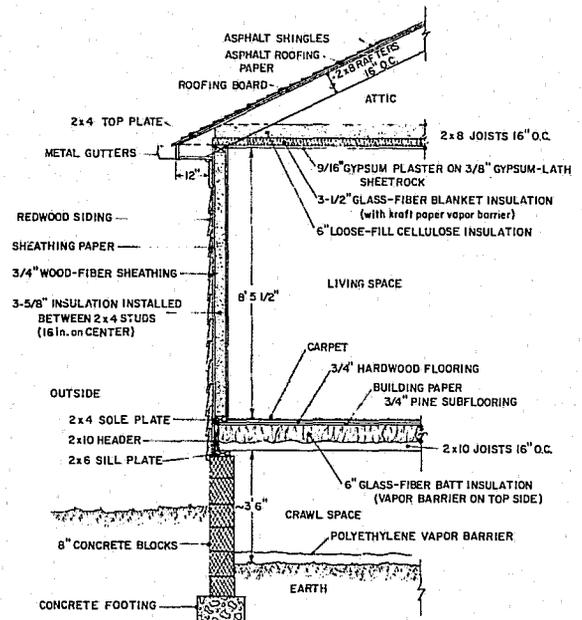
FIGURE 1. Typical cross-section of the house after retrofitting.

- 2 x 4 wood studs
- 3/4-in wood-fiber sheathing sheathing paper
- 7/16-in redwood siding

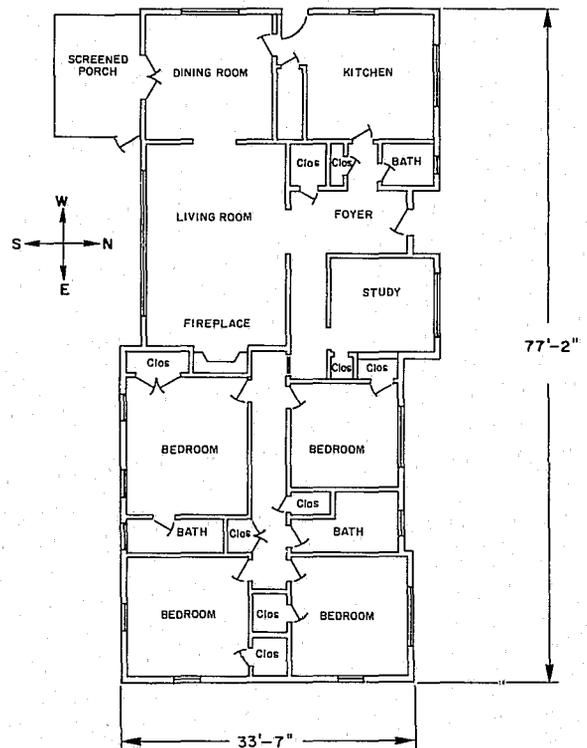
FIGURE 2. Floor plan of the test house.

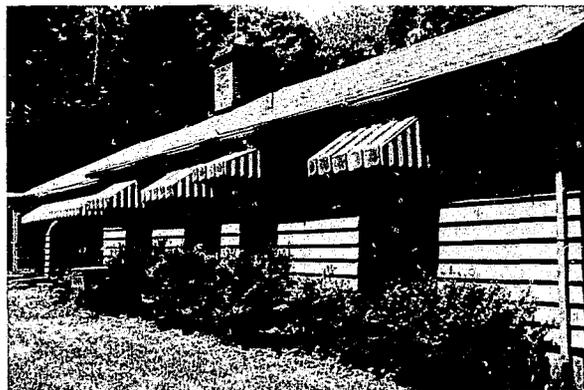
FIGURE 4. A photograph of the south side of the house showing the awnings.

Before the post-retrofit summer cooling energy measurements, aluminum awnings were installed above the windows on the south side of the test house. A photograph of the south side of the test house after the awnings were installed is given in figure 4.

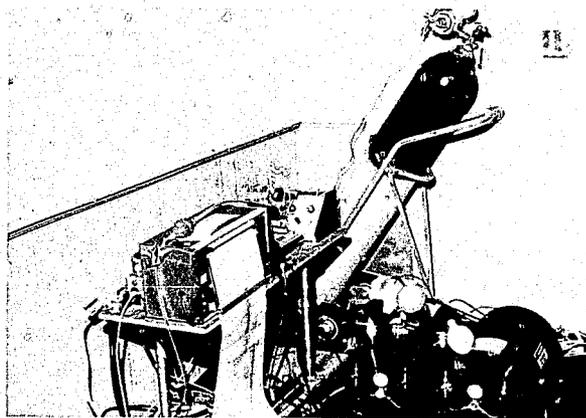
FIGURE 5. Apparatus used to measure air-leakage rates for the test house.

Sulfur-hexafluoride concentrations were measured with a gas chromatograph equipped with an electron-capture detector. A photograph of the measurement apparatus is shown in figure 5.

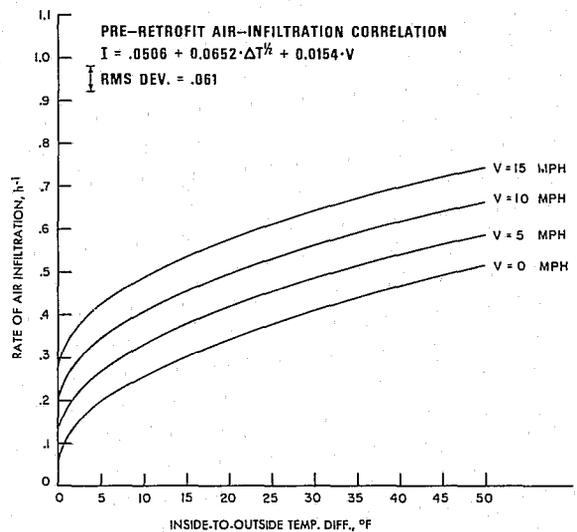
FIGURE 6. Pre-retrofit air-infiltration correlation.

A plot of eq (7) is given in figure 6. Under typical winter conditions, $\Delta T = 35^\circ\text{F}$ (19.4°C) and $V = 7$ mph (3.1 m/s), the rate of air infiltration is roughly 0.5 air changes per hour. At design conditions, $\Delta T = 55^\circ\text{F}$ (30.6°C) and $V = 15$ mph (6.71 m/s), the air-infiltration rate for the test house is 0.75 air changes per hour. These figures indicate that the test house in its original state had low air-leakage rates, due to good construction and good weather-stripping around the doors and windows.

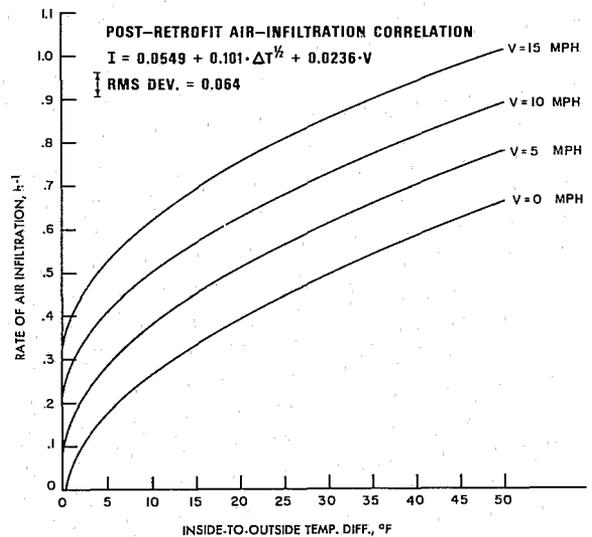
FIGURE 7. Post-retrofit air-infiltration correlation.

Eq (9) is plotted in figure 7.

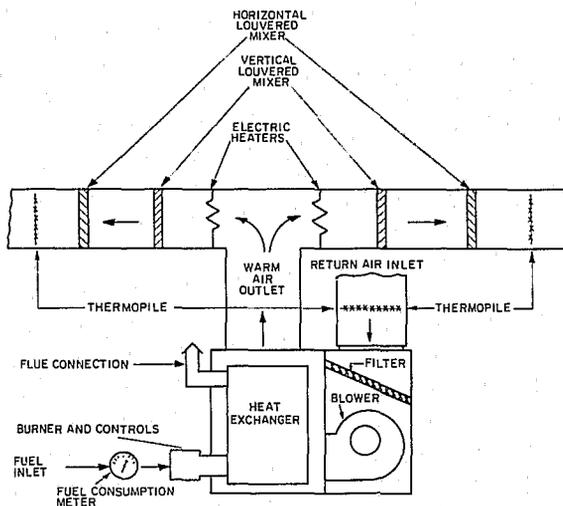
FIGURE 8. Schematic diagram of furnace system showing the location of measuring transducers.

In order to obtain meaningful duct velocity and temperature rise measurements, it is necessary that the measurements be made at a station in the duct having nearly uniform temperature profiles. A schematic diagram of the original oil-fired furnace system showing the location of the measurement transducers is shown in figure 8. Note that the air-delivery duct system has two major supply branches, one delivering conditioned air to rooms located over the basement, the other feeding the rooms located over the crawl space. For the pre-retrofit heating-energy measurements, uniform temperature profiles were created in each major supply branch by installing louvered air-mixing devices which were constructed according to specifications given in reference [18]. The heating

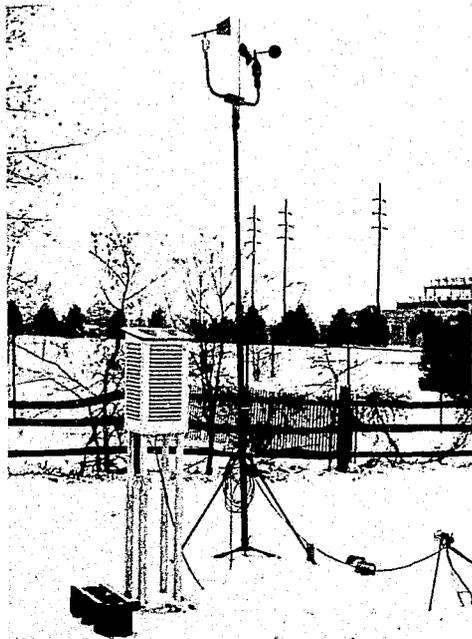
direction vane. The louvered enclosure shown in figure 9 contained a copper-constantan thermocouple for measuring outdoor temperature and a humidity-sensing element which produced a millivolt signal proportional to relative humidity. During the pre-retrofit heating energy measurements, the total solar radiation incident on a horizontal surface was measured with a pyranometer mounted on top of the louvered enclosure shown in figure 9. After the pre-retrofit heating energy measurements, the pyranometer was relocated on the roof of the test house. The outdoor ambient temperature was also measured with thermocouples installed on the north side of trees located behind the test house.

A photograph of the weather station used in the present study is shown in figure 9. This weather station was located approximately 60 ft (18.3 m) in front of and in line with the west end of the test house. This particular location was selected so that the wind direction and velocity sensors, mounted at the 18-ft (5.5 m) level, would be exposed to the prevailing winter northwest wind. Wind velocity was measured with a rotating-cup anemometer, and wind direction was measured with a wind-

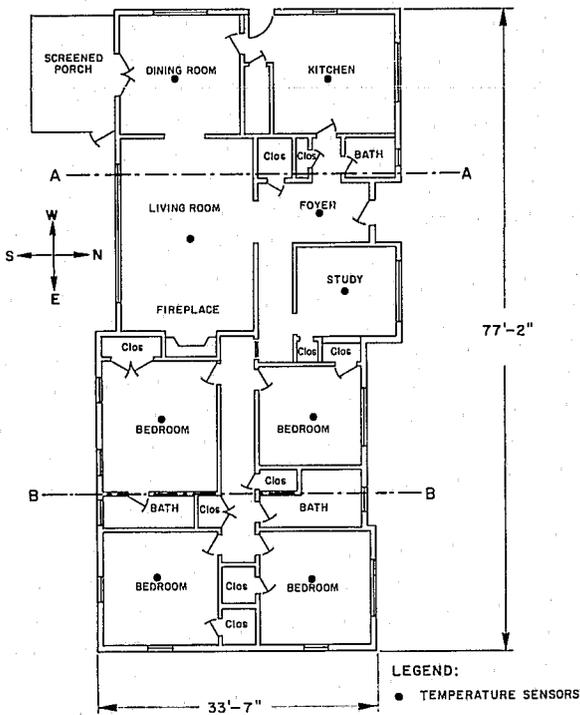
FIGURE 10. Floor plan of test house showing location of temperature sensors.

A relative humidity sensor (the same type that was used in the weather station) was placed indoors in the center of the living room next to the mid-height thermocouple. For the post-retrofit measurements, identical relative humidity sensors were installed in the crawl space, basement, and the attic. In all cases, an ambient air temperature thermocouple was placed next to each humidity sensor.

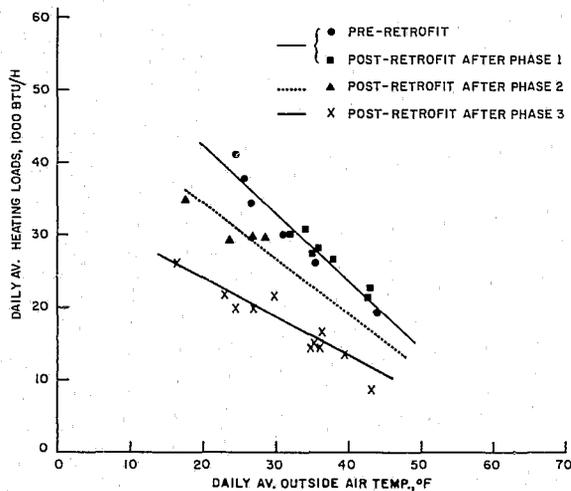
FIGURE 11. Measured heating loads for the unoccupied test house after various stages of the retrofit.

Since the measured daily-average heating loads for the unoccupied test house are approximately equivalent to heat-loss rates, relations (11) and (12) were used to normalize the measured heating loads for the unoccupied test house to the average wind velocity (4.2 mph (1.88 m/s)) and average indoor temperature (67.9°F (19.9°C)) of all the winter heating energy measurements. Normalized daily-average heating loads of the unoccupied house before and after the various stages of the retrofit are plotted as a function of daily-average outdoor air temperature in figure 11. The straight lines were obtained from a least-squares procedure.

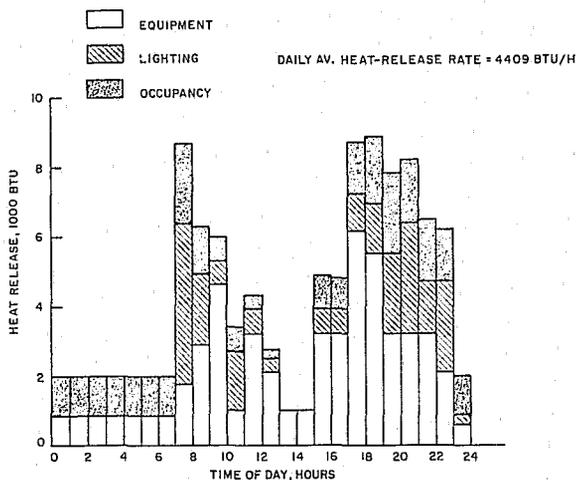
FIGURE 12. Energy-release rates for equipment, lighting, and occupancy.

plant during each hour of every test. If the test house had been occupied, the heat released by occupant-related activities would never have been sufficient to satisfy the heating load of the house over the conditions for which the house was tested. Therefore, the daily-average heating load for the test house, having an occupancy schedule of figure 12, would be equal to the heating load for the unoccupied test house (see fig. 11), less the daily-average heat-release rate for the occupancy schedule of figure 12.

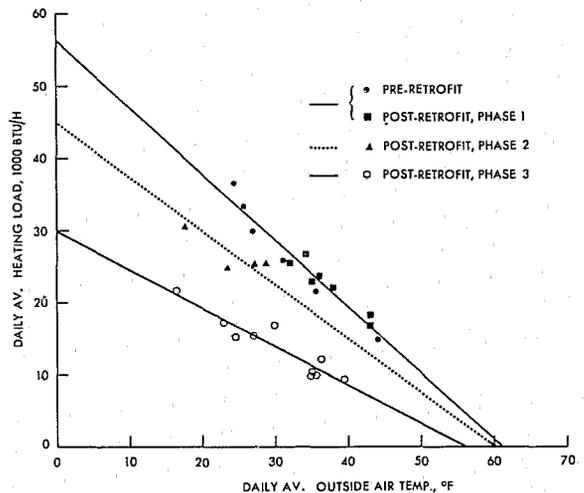
FIGURE 13. Heating-load correlations for the occupied test house after various stages of the retrofit.

The first term in the foregoing equations represents the heat-loss rate from the test house. The second term represents daily-average internal heat-release from occupancy, lighting, and equipment, and heat gain from solar radiation through the windows. Recalling that the daily-average heat-release rate for the occupancy schedule is 4,409 Btu/h (1,291 W), it is seen that the average solar load is calculated to be 1,971 (557 W) and 1,731 Btu/h (507 W), respectively, which are not unreasonable figures.

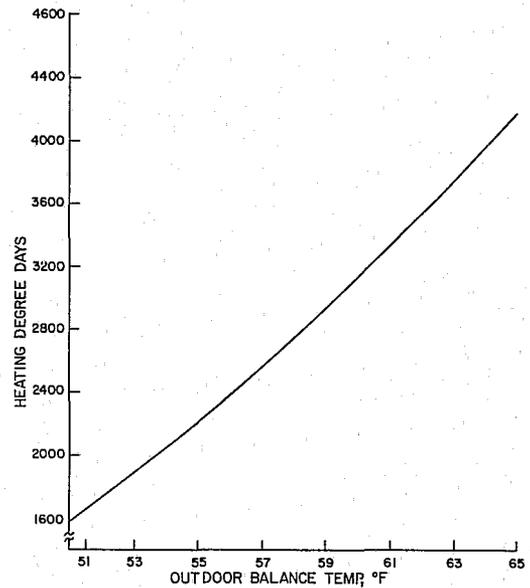
FIGURE 14. Heating degree days as a function of outdoor balance temperature for Washington, D.C.

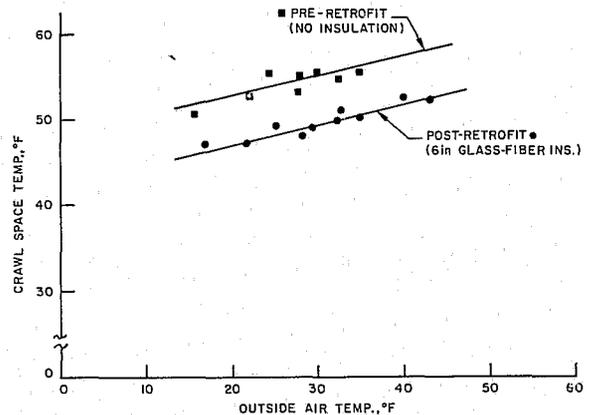
FIGURE 15. Pre- and post-retrofit winter crawl-space temperatures.

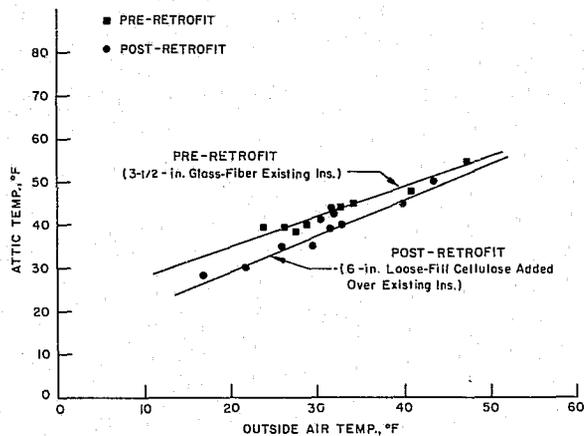
FIGURE 16. Pre- and post-retrofit winter attic temperatures.

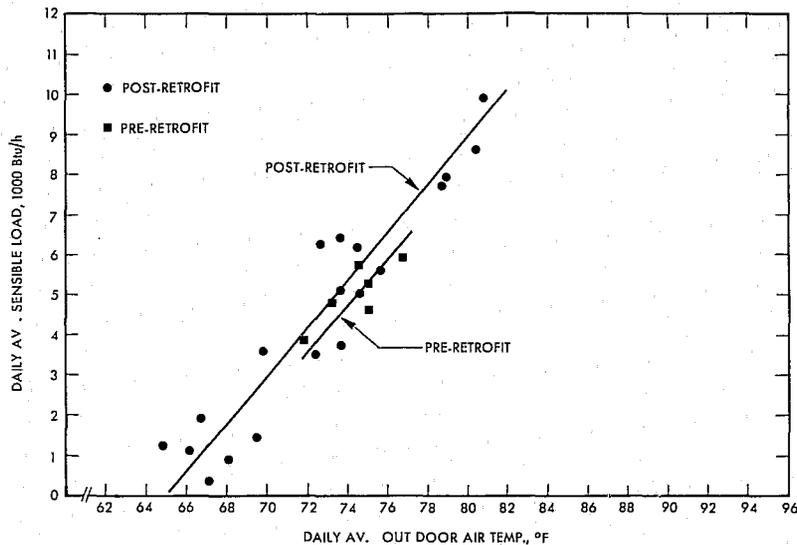
FIGURE 17. Pre- and post-retrofit sensible cooling loads.

FIGURE 18. Pre- and post-retrofit latent cooling loads.

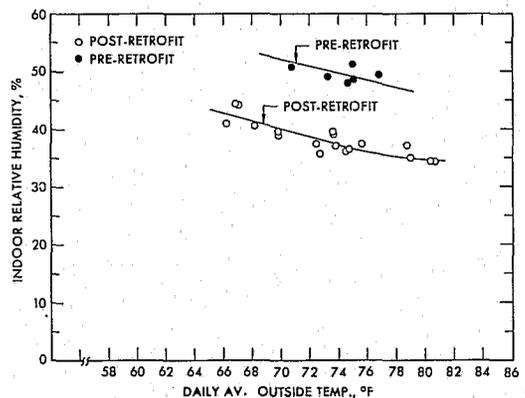
FIGURE 19. Pre- and post-retrofit summer indoor relative humidities.

The reductions in latent load were attributed to a change in the relative humidity levels in the living space. As shown in figure 19, the relative humidity in the first-floor living space was significantly reduced after the retrofit. The reduction in indoor

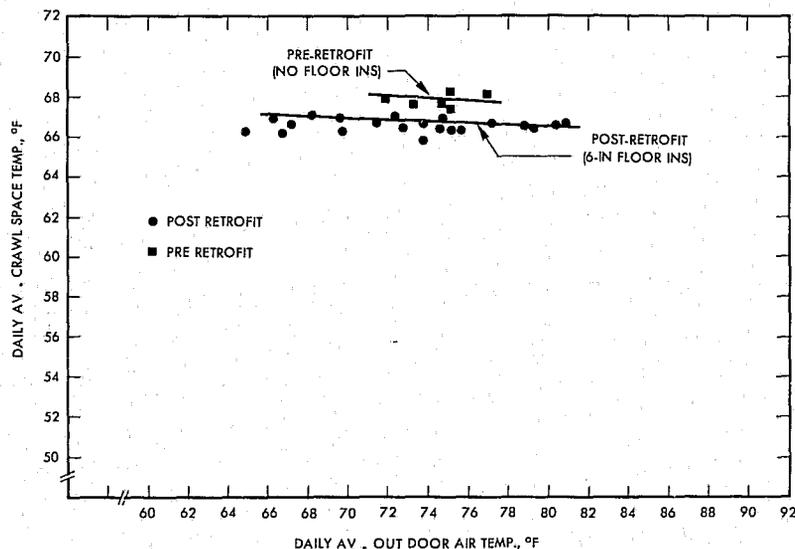
FIGURE 20. Pre- and post-retrofit daily average summer crawl space temperatures.

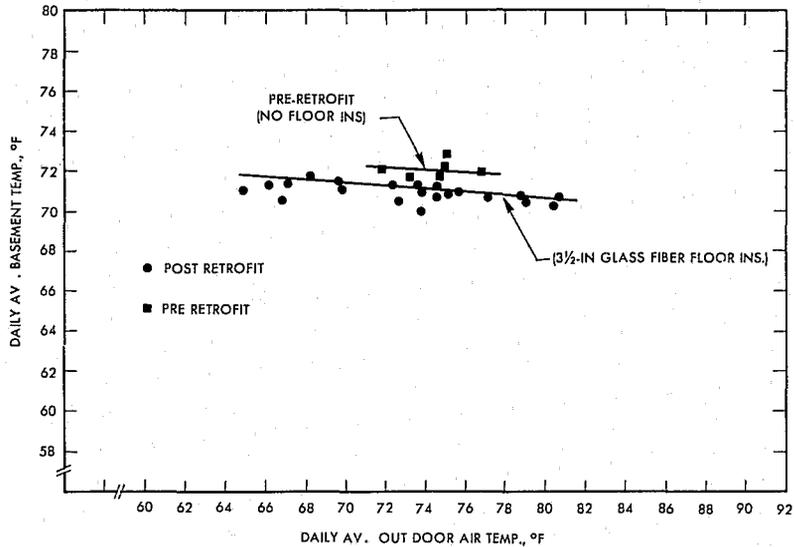
FIGURE 21. Pre- and post-retrofit daily average summer basement temperatures.

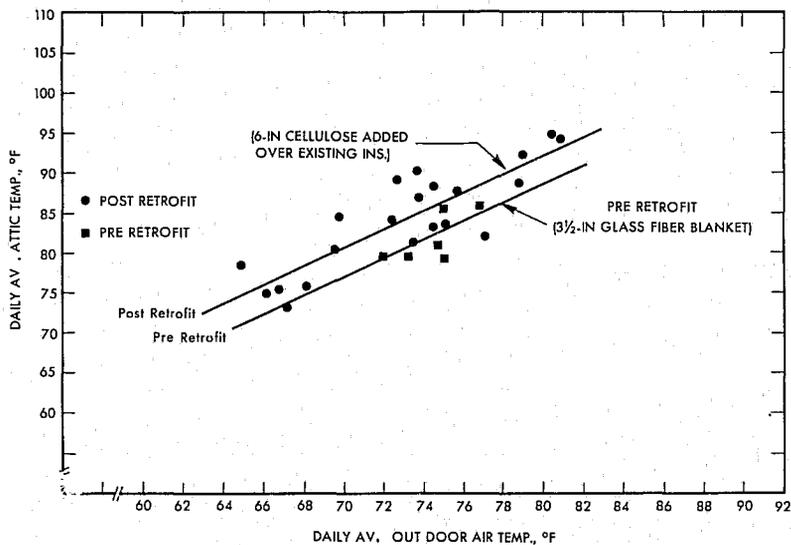
FIGURE 22. Pre- and post-retrofit daily average summer attic temperatures.

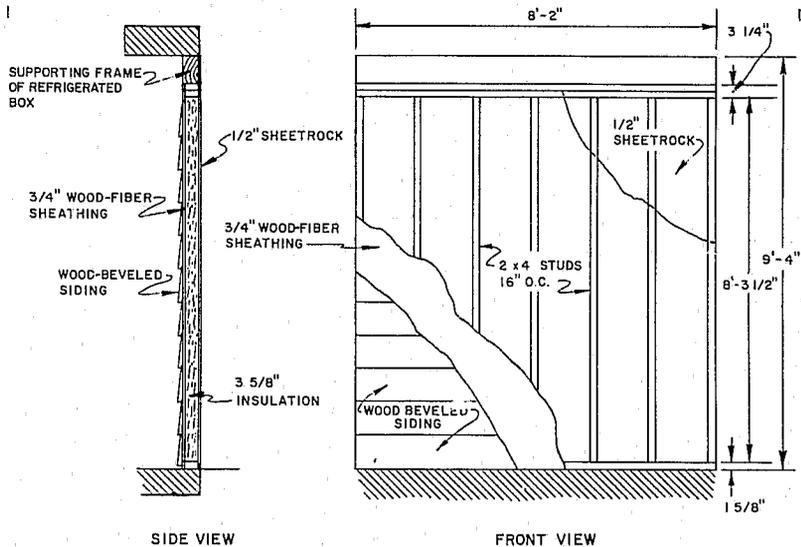
FIGURE 23. Construction details of laboratory test wall.

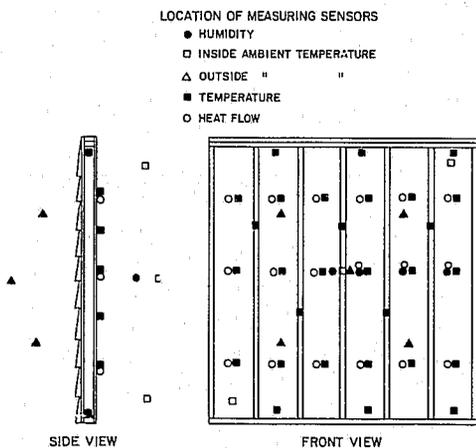
FIGURE 24. Location of measurement transducers on laboratory test wall.

Front and side views of the test wall showing the location of the measurement transducers are given in figure 24. Each pair of wall cavities insulated with different material was instrumented in a similar

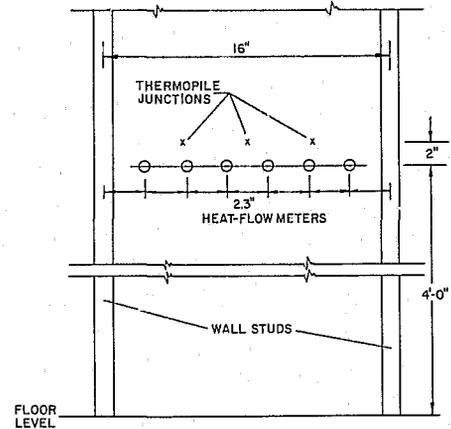
FIGURE 26. Elevation view of wall section of the test house showing heat-flow measuring station.

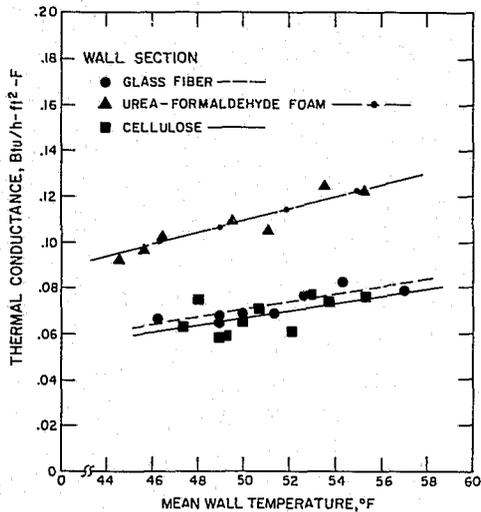
FIGURE 27. The effect of mean wall temperature on the thermal conductance of the three separate wall sections.

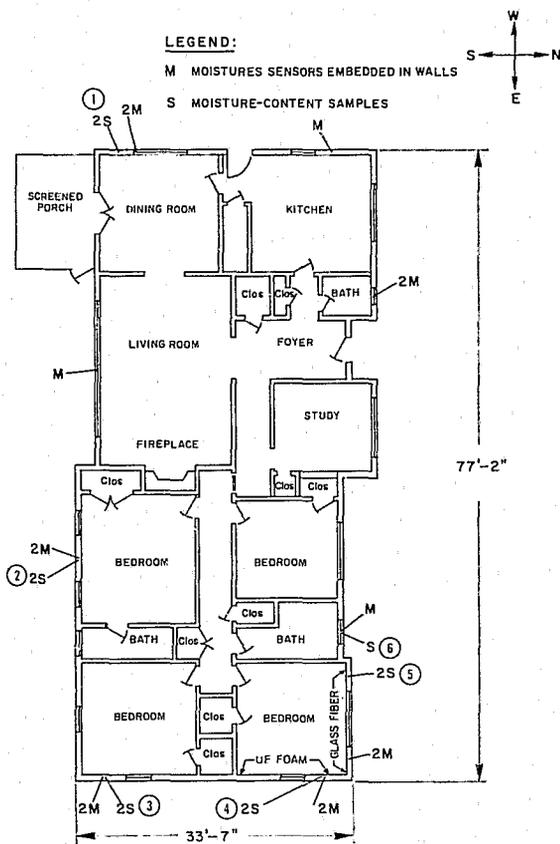
FIGURE 28. Floor plan of the test house showing location of humidity sensors and place where moisture content samples were cored out.

^a See figure 28 for location identification.

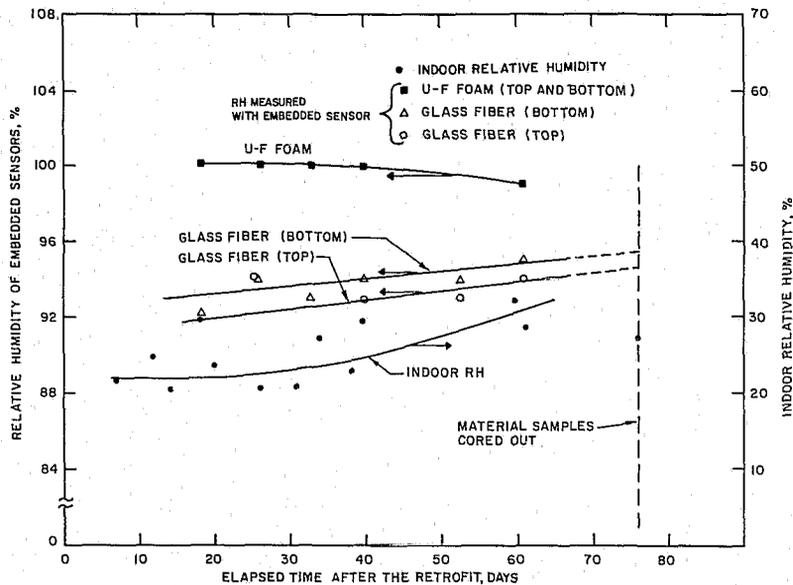
FIGURE 29. Variation of indoor relative humidity and relative humidities of embedded sensors.

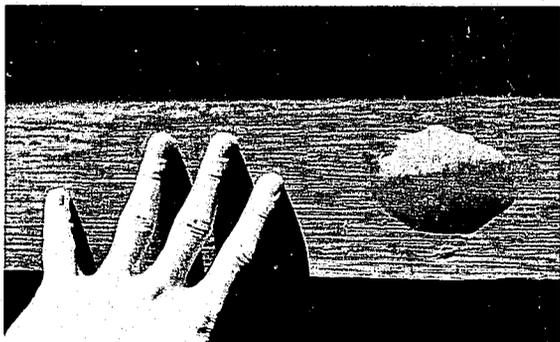
FIGURE 30. Water blister at exterior surface of U-F wall section.

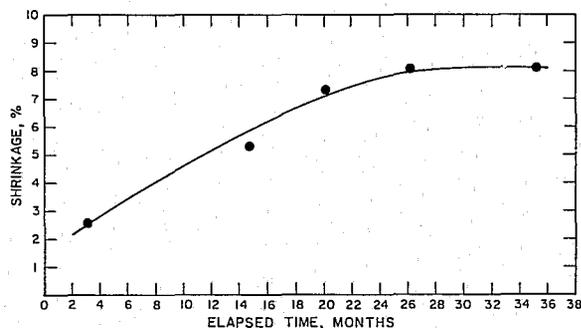
FIGURE 31. Percent linear shrinkage of urea-formaldehyde foam insulation as a function of elapsed time.

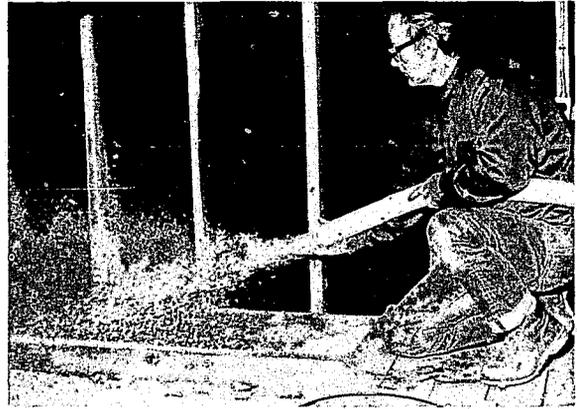
FIGURE A-2. Loose-fill cellulose being blown on top of the existing ceiling insulation.

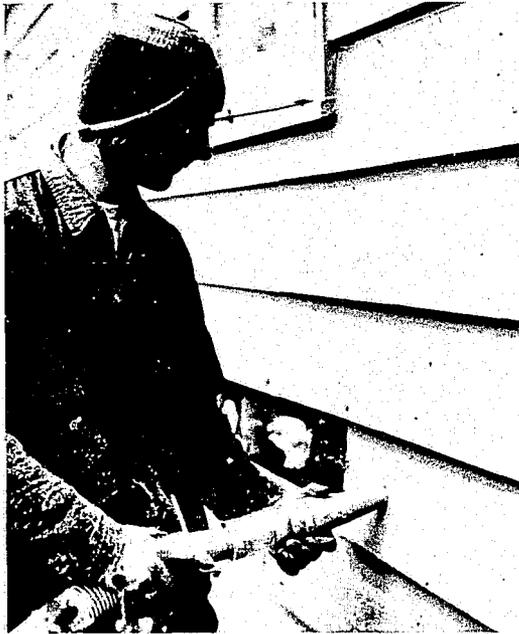
FIGURE A-3. Cellulosic fiber being blown into the walls of the test house.

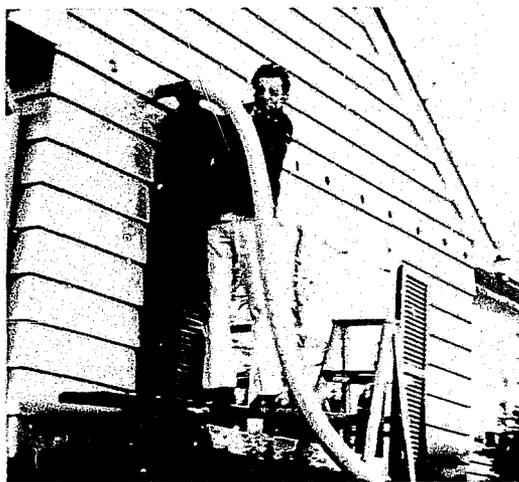
FIGURE A-4. Glass fiber being blown into a wall section.

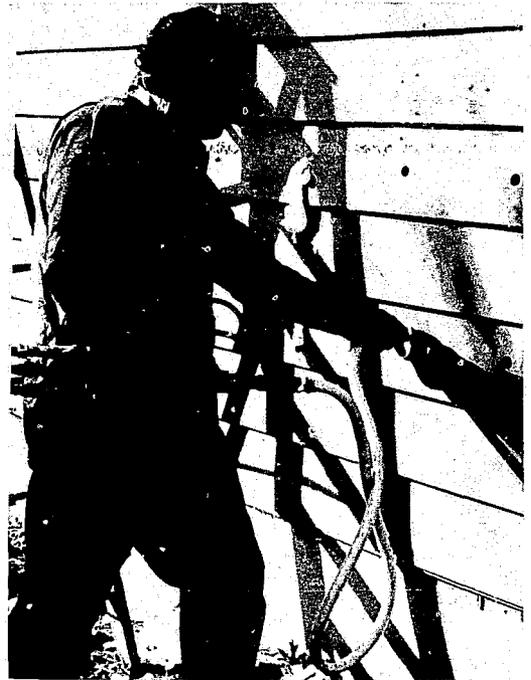
FIGURE A-5. Urea-formaldehyde foam being blown into a wall section.

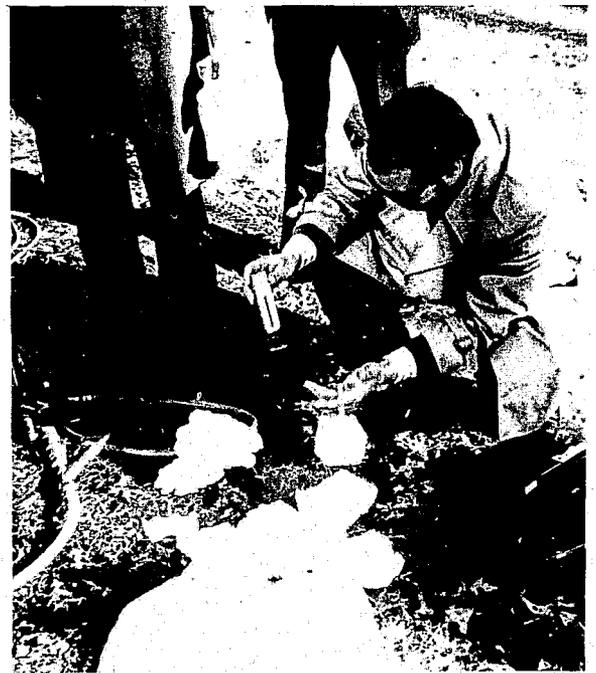
FIGURE A-6. Technical representative measuring wet density of the U-F foam.

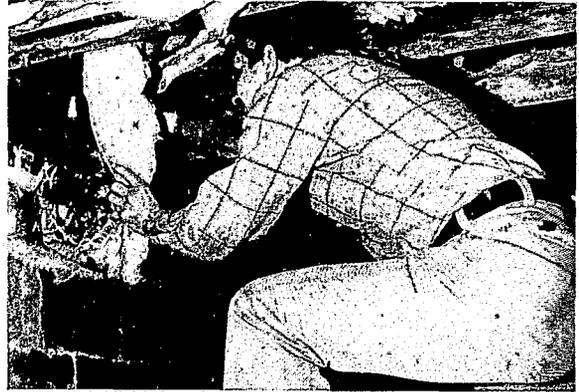
FIGURE A-7. Glass-fiber batts being installed under the floor in the crawl space.

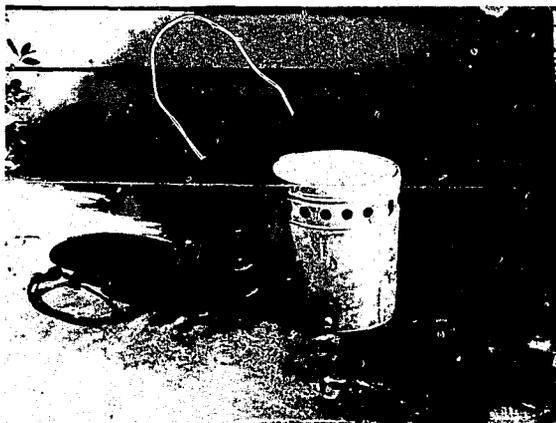
FIGURE C-1. Drum-type smoke distributor.

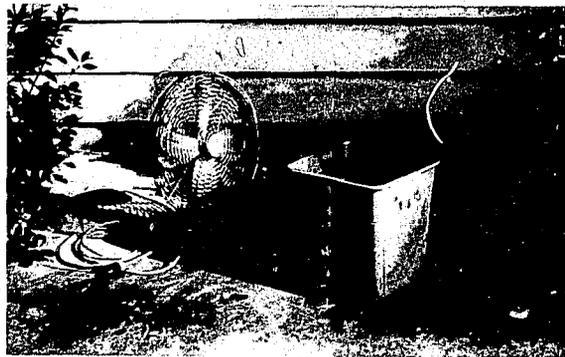
FIGURE C-2. Fan and metal trash basket used to distribute white pyrotechnic smoke.

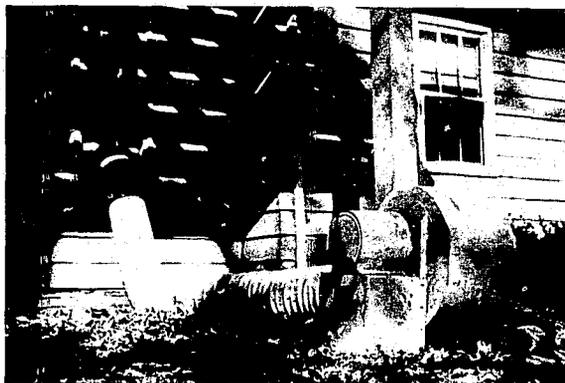
FIGURE C-3. Centrifugal blower connected to the window panel with a flexible hose.

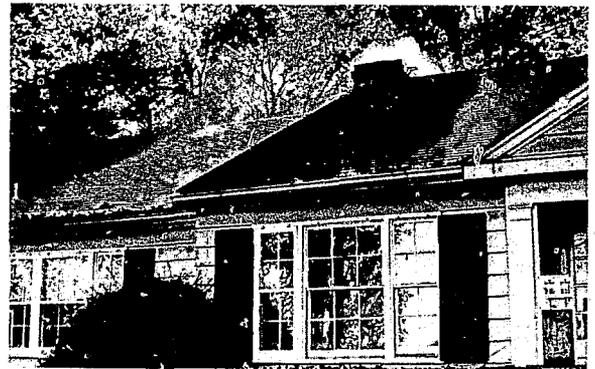
FIGURE C-4. Major air leakage path through the chimney.

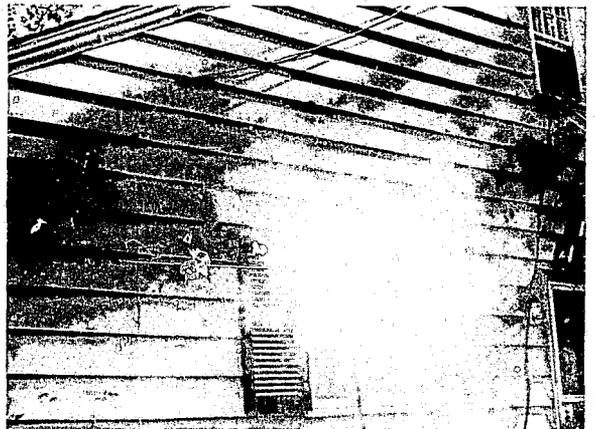
FIGURE C-5. Major air leakage path through kitchen exhaust opening.
