SIREN **STANDARDS**

California Highway Patrol

July 1978

SIREN STANDARDS

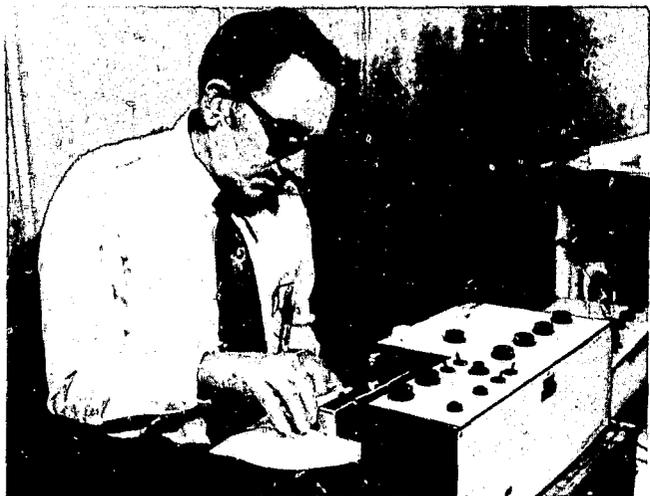
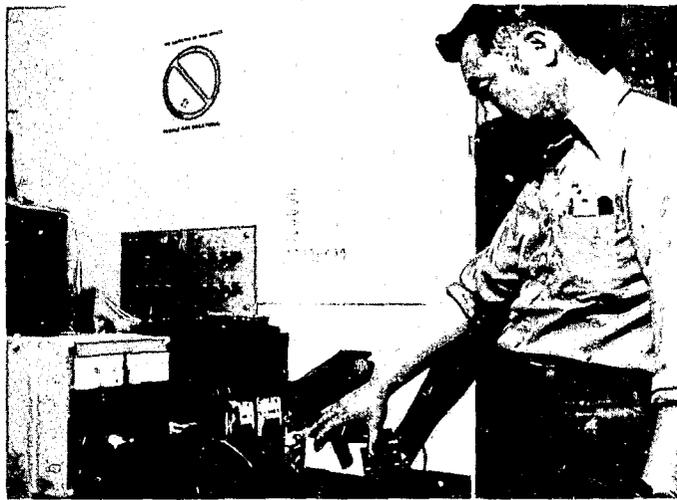
Figure 24. Siren Tests at Sacramento State University

at California State University, Sacramento. Highway Patrol Engineers conduct the tests with CHP equipment, thereby controlling the calibration and repair of the instruments. (see Figure 24)

Testing of sirens for approval in California continues with tests performed in the anechoic chamber
