Document Title: Technical Evaluation of the TRP-1000 and ACU-1000: Test Procedures and Results

***Technical Evaluation of the TRP-1000 and ACU-1000
-Test Procedures and Results
Document No. TE-00-0002-01***

August 25, 2000

Prepared by
OLES / Institute for Telecommunication Sciences
325 Broadway
NTIA/ITS.P
Boulder, Colorado 80305

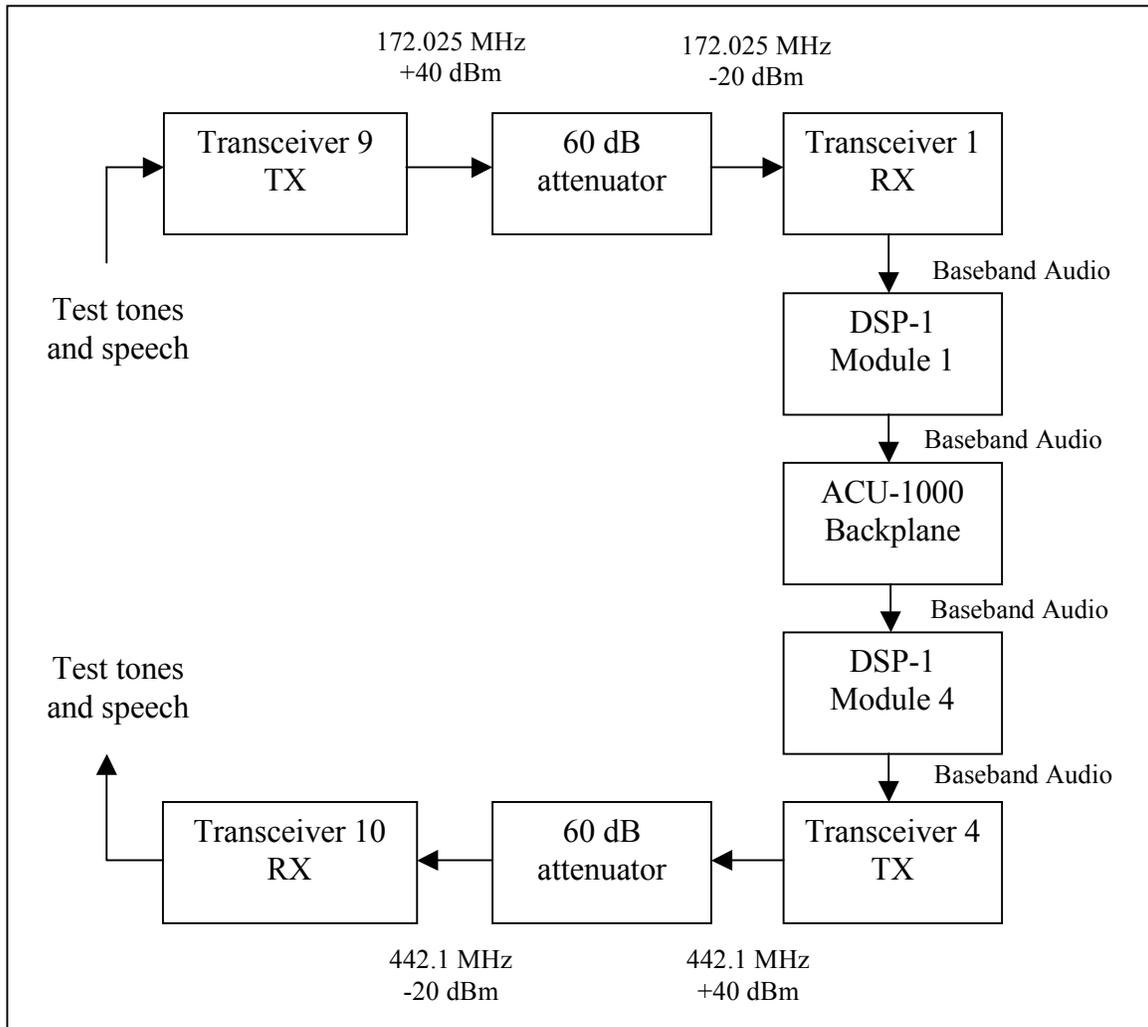
Figure 1. VHF to ACU-1000 to UHF case (VAU case).

Transceivers 9 and 10 were disconnected from the ACU-1000 for all four cases. Audio connections to these transceivers were made via the transceiver audio input (TXA and TXB) and audio output (RXA and RXB) signal lines provided in dB-15 connectors on the TRP-1000 back panel. These signal lines were unbalanced and connections were made accordingly. Transceivers 1, 2, and 4 were disconnected from the ACU-1000 for some of the direct patch cases. When disconnected from the ACU-1000 audio connections to these transceivers were made via the transceiver audio input (TXA and TXB) and audio output (RXA and RXB) signal lines provided in DB-15 connectors on the TRP-1000 back panel. These signal lines were unbalanced and connections were made accordingly.

For the VAU case, the audio path was established by pulling the PTT line of transceiver 9 to ground at the DB-15 connector on the TRP-1000 back panel. For the UAV case, the audio path was established by pulling the PTT line of transceiver 10 to ground. In the VDU case, the PTT lines of transceivers 9 and 4 were pulled to ground. In the UDV case, the PTT lines of transceivers 10 and 1 were pulled to ground.

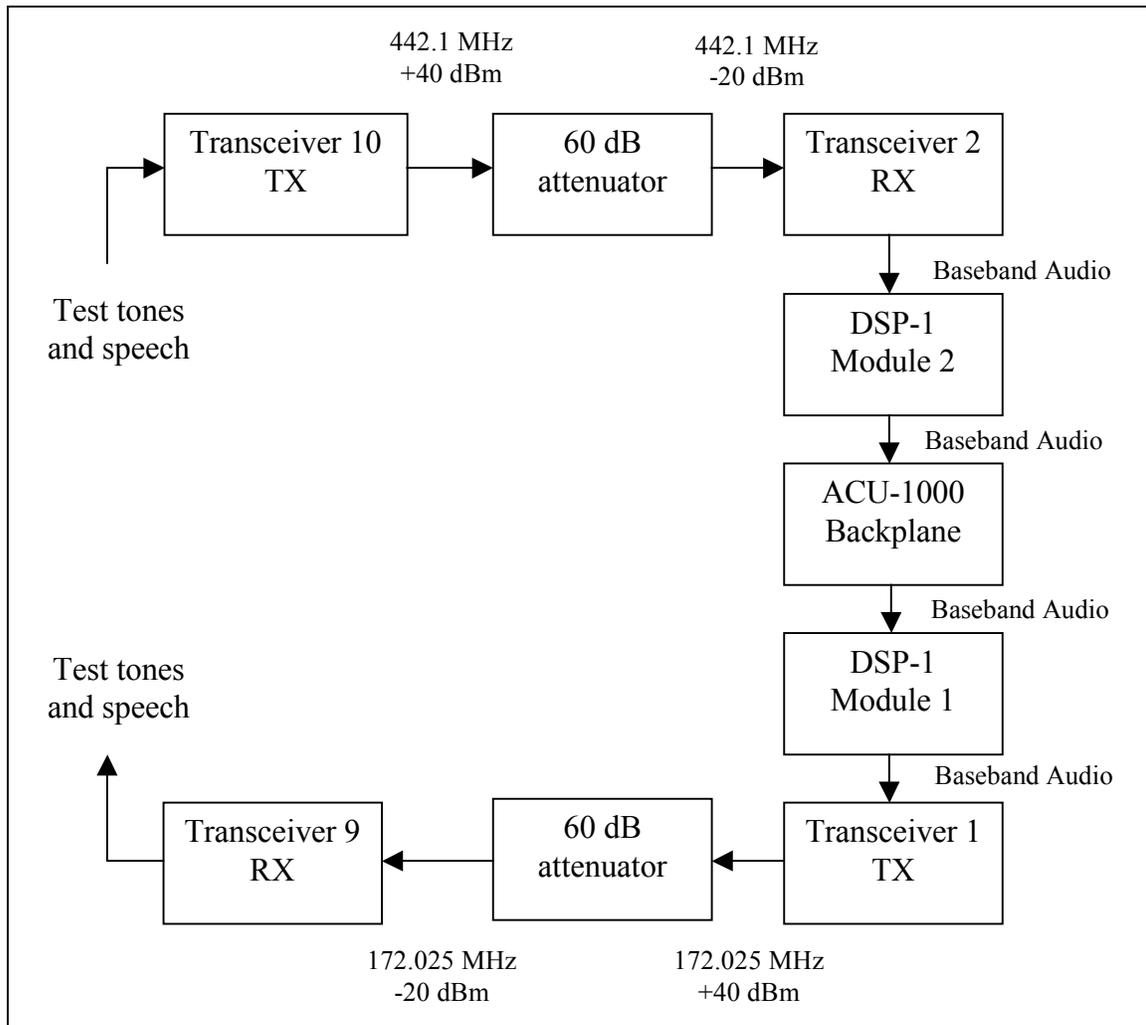
Figure 2. UHF to ACU-1000 to VHF case (UAV case).

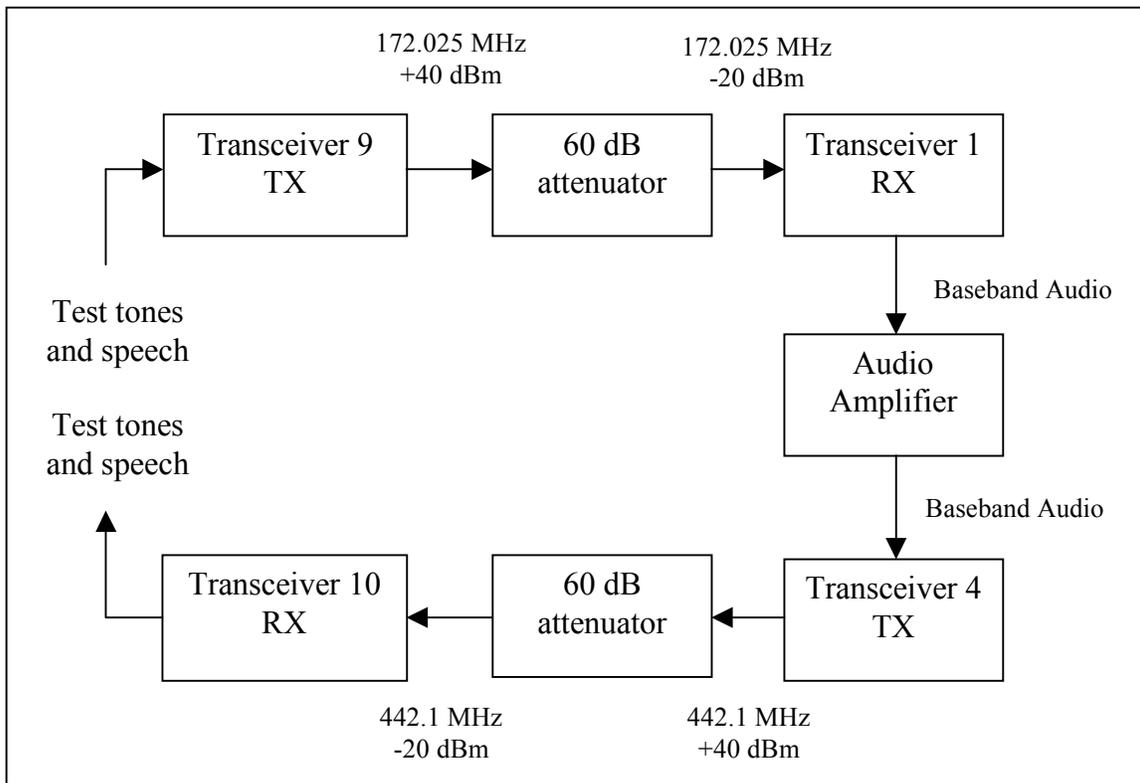
Figure 3. VHF directly patched to UHF case (VDU case).

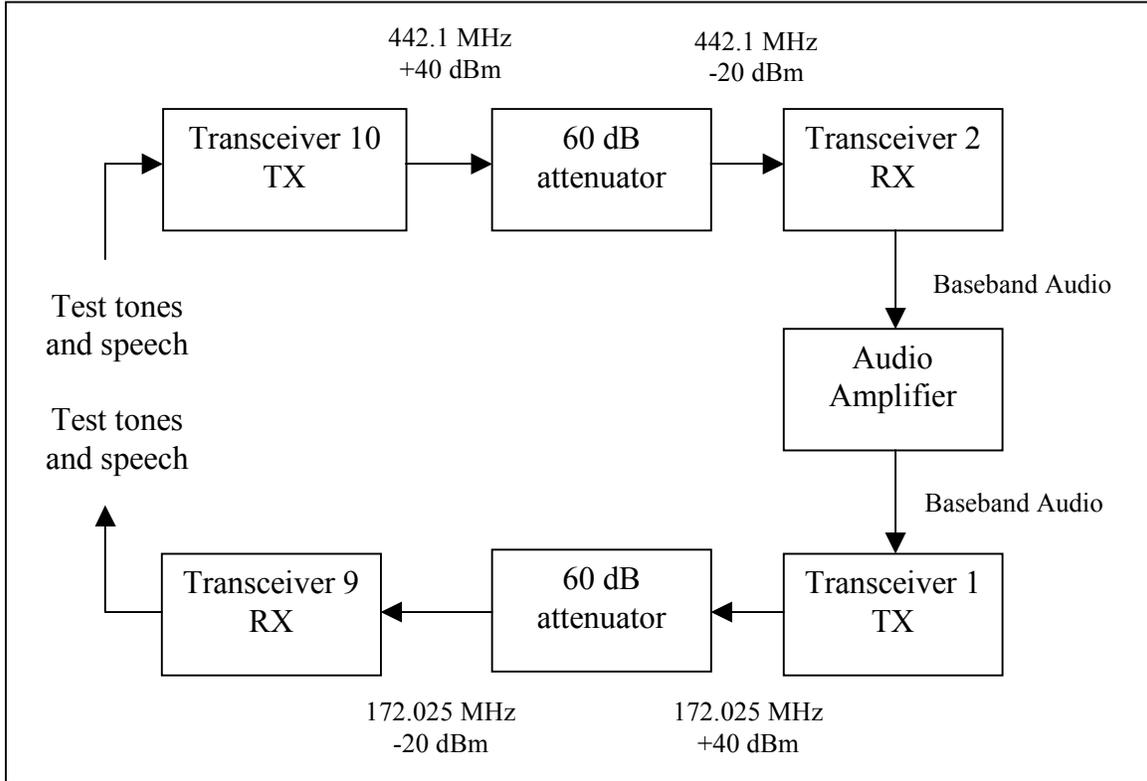
Figure 4. UHF directly patched to VHF case (UDV case).

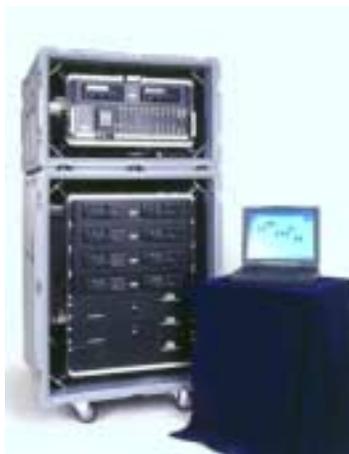
The MARIP TRP-1000 audio cross-connect system is shown in Figure 5. It is a transportable unit consisting of two chassis, each containing shock-mounted 19" equipment racks permanently affixed inside a ruggedized shipping container. The upper chassis consists of an ACU-1000 controller, two mobile radios (one VHF and one UHF), and power supply for the radios. The lower chassis houses eight radios (four mobile VHF and four mobile UHF) and four power supplies. The two chassis are interconnected by DB-15 cables, enabling the routing and control of the radios by the ACU-1000 controller. A laptop computer is supplied with the TRP-1000, with radio programming software and console interface control software pre-installed.

Figure 5. TRP-1000.⁴

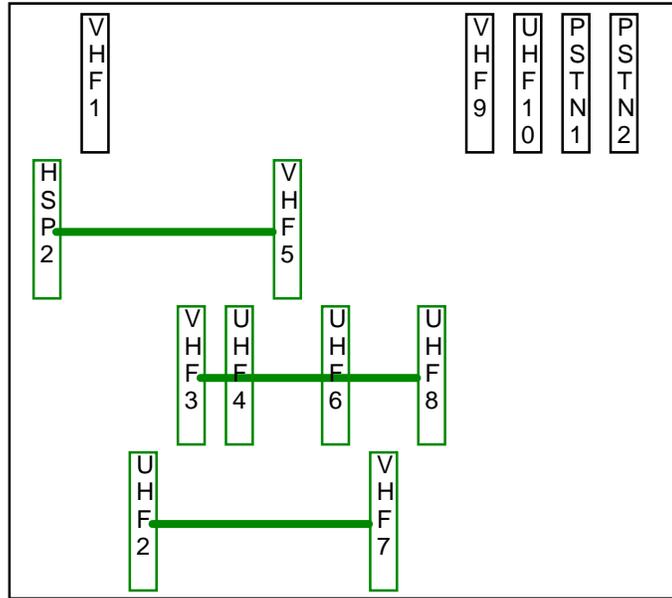
Figure 6. Example network configuration.

35. Establish the network configuration shown in Figure 6. Assume equipment failure of a radio. Note that whichever chassis of the TRP-1000 contains the failed radio,

36. Verify system behavior in the event of AC power failure. Establish the net configuration shown in Figure 6 with the security configuration of steps 31 and 32. Simulate an AC power failure by simultaneously disconnecting the AC power cords to the computer and TRP-1000 from the electrical outlets. The laptop computer should continue to function uninterrupted under its own battery power. The TRP-1000 should power off. Reconnect the AC power cords to the electrical outlets. The TRP-1000 system reboots. At the computer, the console interface software will display a warning message. Click . On the menubar of the JPS console interface software application, under “Operations,” select “Get Configuration from ACU.” At the prompt to save the current configuration, click . On the menubar under “Configuration,” select “Security SetUp.” Note that PIN information, security mode, and module security level information has been retained from the last configuration before the power failure. Click . Note that all network links have been lost. This can be verified using radios VHF9 and UHF10 and noting the indications and behavior of the ACU-1000 and radios VHF1 – UHF8.

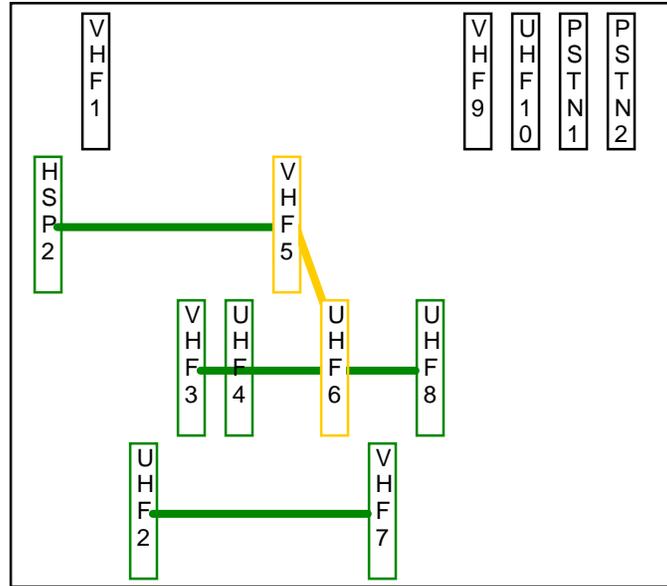
Figure 7. Example network configuration with two interconnected nets.

23. Select a channel on VHF9 and UHF10 that corresponds to one of the networks created in steps 20 – 22. For example, using the situation shown in Figure 7 and referring to the channel plan described in Table 7, tune radio VHF9 to channel 22 (same as VHF3’s frequency) and radio UHF10 to channel 23 (same as UHF6’s frequency). When PTT is asserted on VHF9, the green carrier detect LED on VHF3 and UHF10 should be illuminated, and the red PTT indicators on radios UHF4, VHF5, UHF6, UHF8, and, of course, VHF9, should be illuminated. The COR LED on ACU-1000 module 03 should be illuminated, as should the PTT LEDs on ACU-1000 modules 04, 05, 06, and 08. Rotating the channel select knob on UHF10 from channels 21 through 25 will let UHF10 participate in the different nets and should, in this example, permit receive audio on UHF channels 22, 23, and 24 *only*.

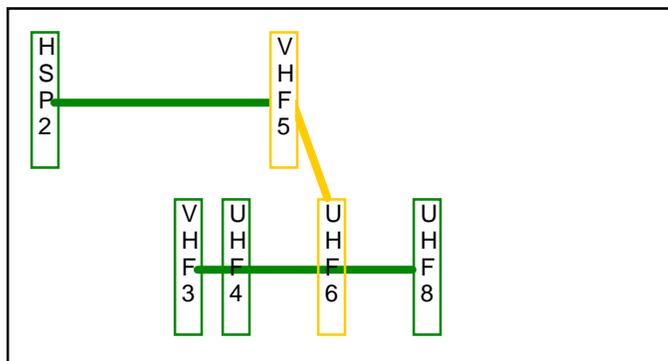
Figure 8. Example network configuration for handset functional check.

25. Verify that group voice communications can be established between the local handset HSP-2 and radios VHF9 and UHF10. For the network configuration shown in Figure 8 and utilizing the channel scheme of Table 6 and Table 7, communications should be possible between the local handset and VHF9 when

VHF9 is tuned to channels 22 and 23 *only*. Communications should be possible between the local handset and UHF10 when UHF10 is tuned to channels 22, 23, and 24 *only*.

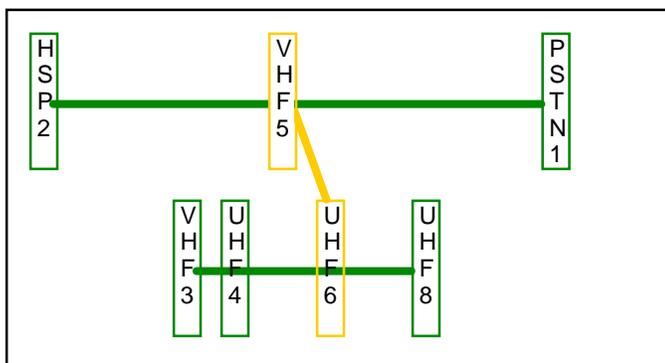
Figure 9. Example network configuration for PSTN functional check.

27. Connect the DTMF keypad microphone to radio VHF9 or UHF10. Depress the PTT switch and dial the PSTN access code [*][1][1] (for PSTN module 11) or [*][1][2] (for PSTN module 12), and release PTT. Dialing [*][1][1] will give the net configuration shown in Figure 9. The PSTN module will be connected to

the radio net once PTT has been deasserted. Next, in response to the voice prompt, assert PTT, dial the desired telephone number followed by [#], and release PTT. Verify that group voice communications can take place between radios VHF9, UHF10, and the telephone. The telephone user must dial [*][#] to disconnect the PSTN module from the net.

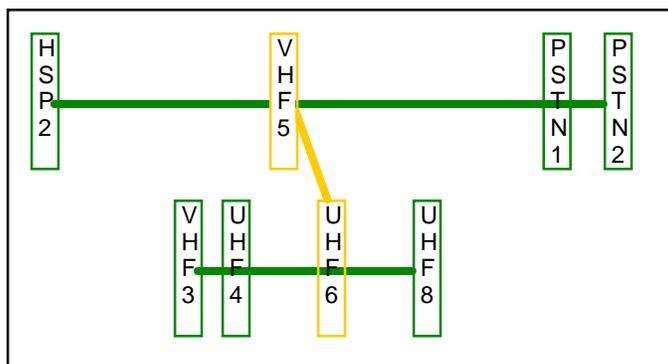
Figure 10. Example network configuration for dual-PSTN module functional check.

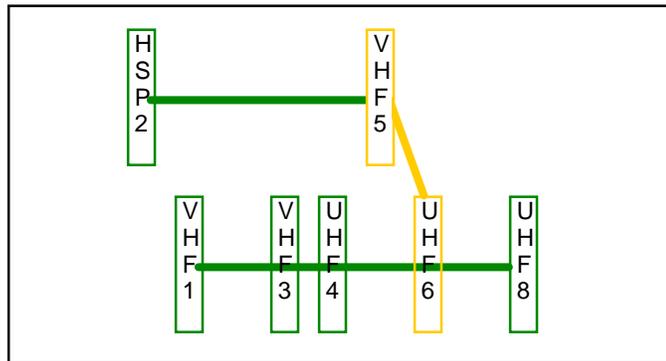
Figure 11. Late entry into a radio net.

29. Verify that a radio user can join a net while the net is idle. Establish the net configuration shown in Figure 8. Tune radio VHF9 to channel 25. This will enable VHF9 to communicate with VHF1 *only*. At this point, VHF1 is not connected to any net. Tune radio UHF10 to channel 23. This will enable UHF10 to communicate with the net shown in Figure 8. Using the DTMF keypad microphone with radio VHF9, depress the PTT switch, dial [*][0][3], and release PTT. After VHF9 deasserts PTT, VHF1 will be connected to the net, as shown in Figure 11, (dialing [*][0][5] would connect VHF1 to the underlying net of HSP-2 and VHF5, however, since the two underlying nets are bridged together, there is no difference in the crossband communications capability insofar as distant users are concerned). Verify that radios VHF9 and UHF10 can communicate with each other. Depress the PTT switch, dial [*][#], and release

PTT to remove VHF1 from the net. The net configuration will revert to that shown in Figure 8.

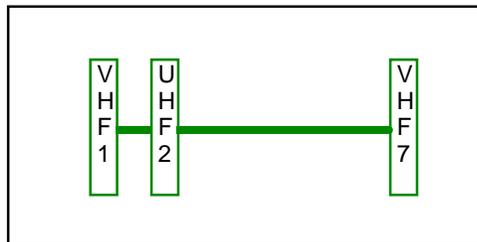
Figure 12. Protected net configuration.

34. Attempt to join VHF9 with the protected (UHF2/VHF7) net by linking VHF1 to the net. The following process describes four attempts to join the protected net; one using an invalid access ID, one using a valid ID but with insufficient access privileges, one with sufficient access privileges, and one with access privileges exceeding that which is required. With radio VHF9 tuned to channel 25 (VHF1's frequency), depress the PTT, dial , and release the PTT. At the “user ID” prompt, depress PTT, enter any number sequence other than the three PINs established in step 32 followed by , and release PTT. The ACU-1000 will respond with “Invalid ID” and deny the connection request (of VHF1 to the UHF2/VHF7 net). Depress the PTT, dial , and release the PTT. At the “user ID” prompt, depress PTT, enter , and release PTT. The ACU-1000 will respond with “Security Violation” and deny the connection request because PIN 1001 has a lower security level access than the UHF2/VHF7 net. Depress the PTT, dial , and release the PTT. At the “user ID” prompt, depress PTT, enter , and release PTT. VHF1 will be added to the net because PIN 1002 has equal security level access to the UHF2/VHF7 net. See Figure 12. Tune UHF10 to channel 25 (UHF2's frequency). Verify that communications can be conducted between radios VHF9 and UHF10. Depress PTT, dial , and release PTT to remove VHF1 from the net. Now depress the PTT, dial , and release the PTT. At the “user ID” prompt, depress PTT, enter , and release PTT. VHF1 will be added to the net because PIN 1003 has a higher security level access than the UHF2/VHF7 net. With UHF10 still tuned to channel 25, verify that communications can be conducted between radios VHF9 and UHF10. Depress PTT, dial , and release PTT to remove VHF1 from the net.

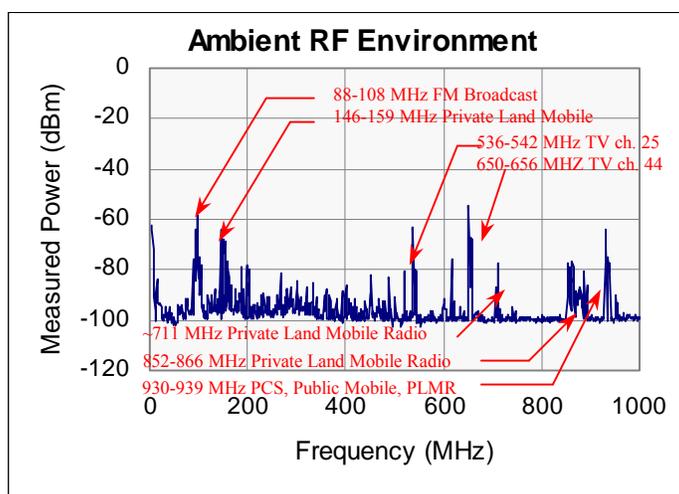
First, a measurement of the ambient RF environment in an unshielded room was taken. This is shown as Figure 13. This “ambient” measurement includes the effects of the measuring system’s computer and spectrum analyzer. Figure 13 also shows the presence of “extraneous” RF sources that are present in the measurement room. These represent typical levels at typical frequencies that would be present in any communications center inside a typical building structure.

Figure 13. Ambient urban RF noise environment. Note the signal levels received from other radio services.

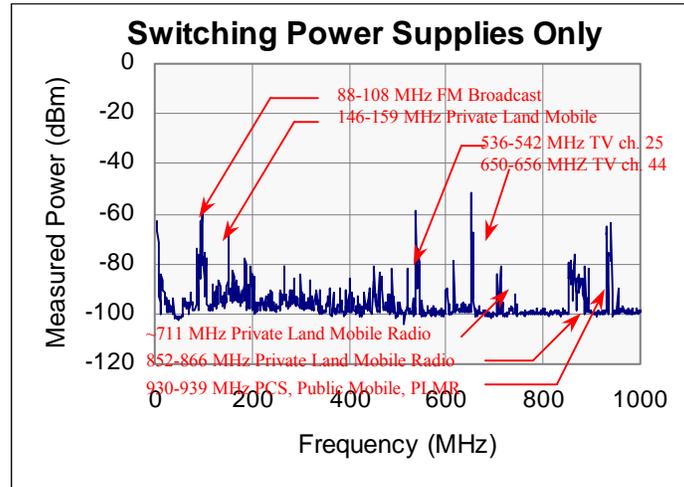
Figure 14. Switching power supplies only.

Various equipments were then sequentially powered on and subsequent measurements of the RF spectrum were collected. In order, all five switching DC power supplies were turned on, then all ten cooling fans were powered on. Next, power was applied to all ten radios, the ACU-1000 controller, and the laptop computer supplied with the TRP-1000. Lastly, a spectrum sweep was collected for the situation where seven of the ten radios were simultaneously transmitting at minimum transmit power (on the order of 10 watts) into dummy load terminations. The radios were tuned to channels near 172 MHz and 442 MHz. Although not representative of a typical operational configuration, as would be the case, say, for example, multiple antennas affixed to the roof of the building and located some distance away from the TRP-1000, the levels of RF leakage from the

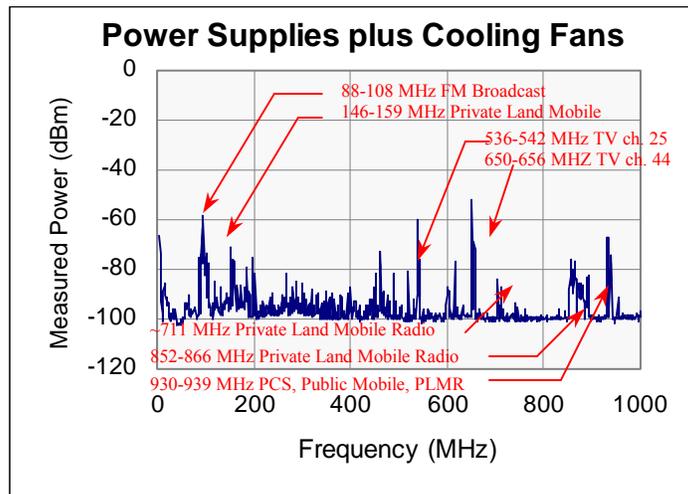
Figure 15. Switching power supplies plus fans.

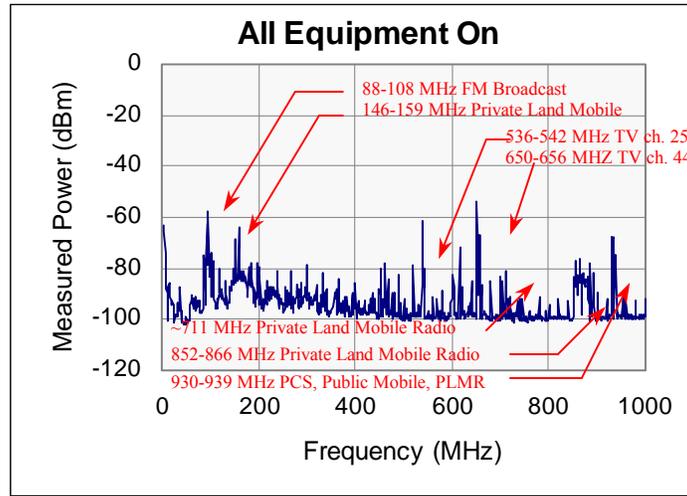
Figure 16. All equipment components powered on.

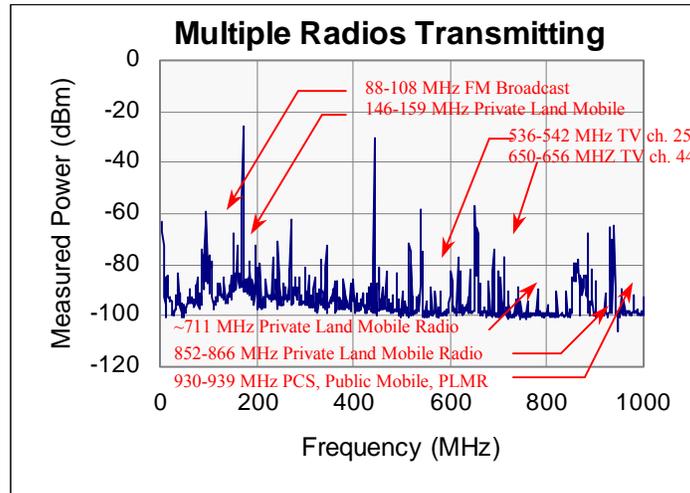
Figure 17. Seven radios simultaneously transmitting into dummy loads.

dummy loads and coax might be considered representative of “worst-case” RF levels likely to be encountered in practice.

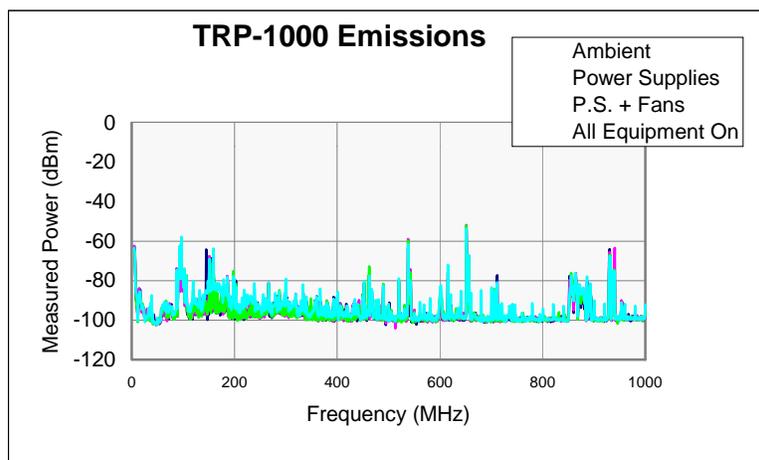
Figure 18. Overlay plot of all measurement conditions except simultaneously transmitting radios.

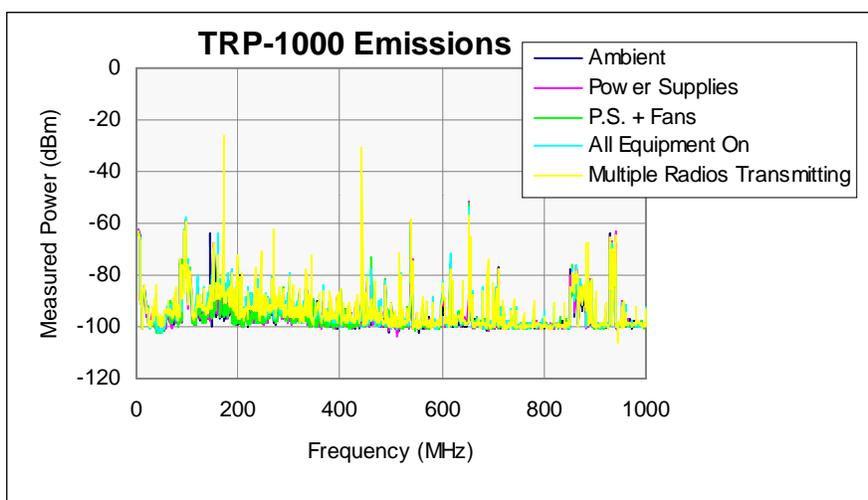
Figure 19. Overlay plot of all measurement conditions including simultaneously transmitting radios.
