NBS Special Publication 480-18 Report on an Investigation of the High Speed Hazards of Steel Belted Radial Tires on Police Patrol Cars

Report on an Investigation of the High Speed Hazards of Steel Belted Radial Tires on Police Cars

by Jared J. Collard Law Enforcement Standards Laboratory Center for Consumer Product Technology National Bureau of Standards Washington, D. C. 20234

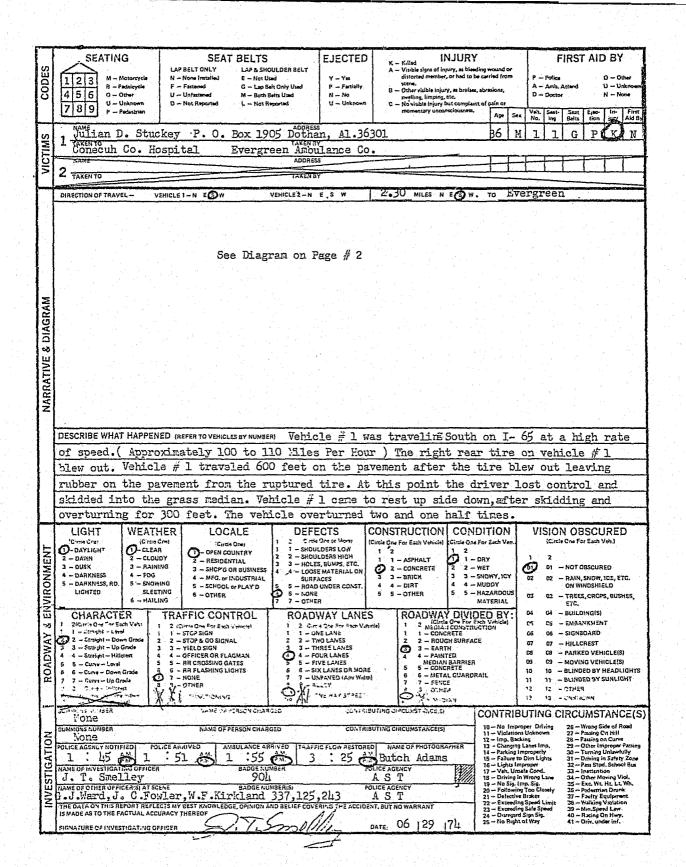
2.30 miles South to Ev			
2.30 littles South to Evi	ergreen		
			7
			Vorth
	I- 65		
		Paved Shoulder	
		Right rear tire blev	out here
	/		
	力匠		B
		4 69	an Ma
		Paved Shoulder	
A COLD	C	rass Median	
	I	Paved Shoulder	
	يود ميستم

I	Paved Shoulder	
			and the second second
Diagram Scale Lines = (20 feet)	Location 1	Interstate # 65	Time A.M
	1 2 2 2	2.30 miles South to Evergreen in Conecuh County	1 40 P.M.
Signature of Reporting Officer(s)	Badge No.	Reporting Police Agency	DATE Month Day Year
Sat Cr 7 Smalley	onl.	Alabama State Trooners	06 27 71
