HAWAII JUDICIAL SYSTEM MASTER PLAN

Volume III

Evaluation of Existing Judicial Facilities

Carter Goble Associates, Inc.
January 1989

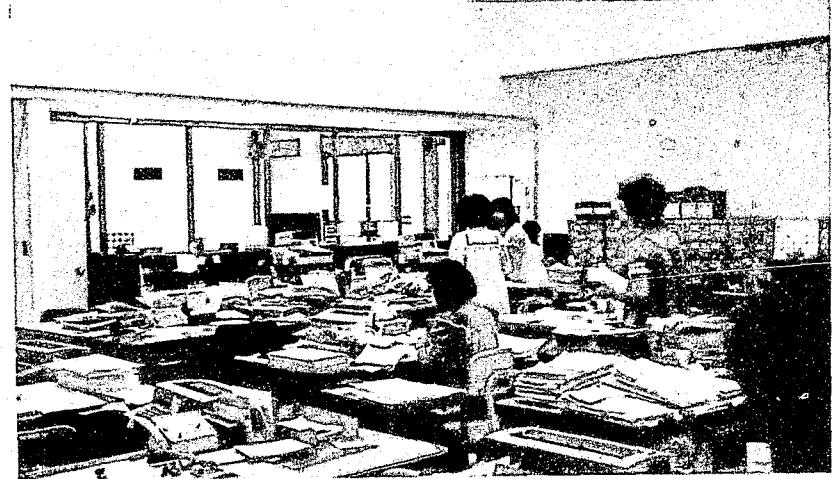
OVERCROWDING IN CLERK'S OPEN OFFICE.

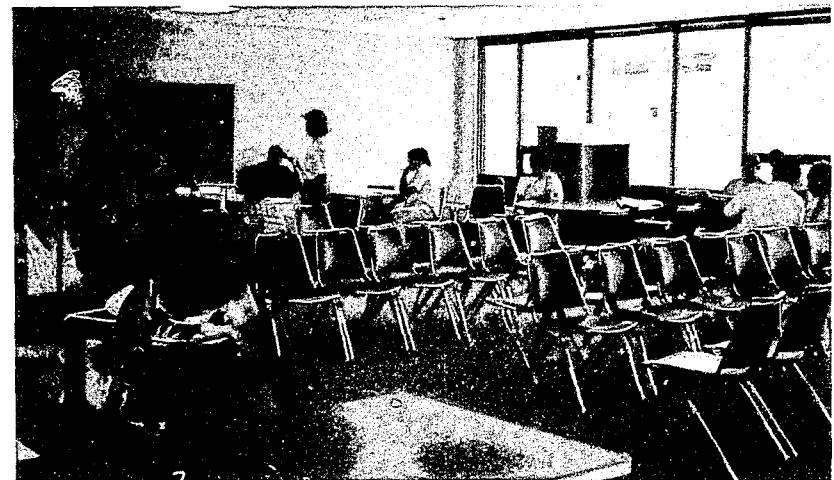
CONSTRAINED WAITING AREA FOR FAMILY COURT.

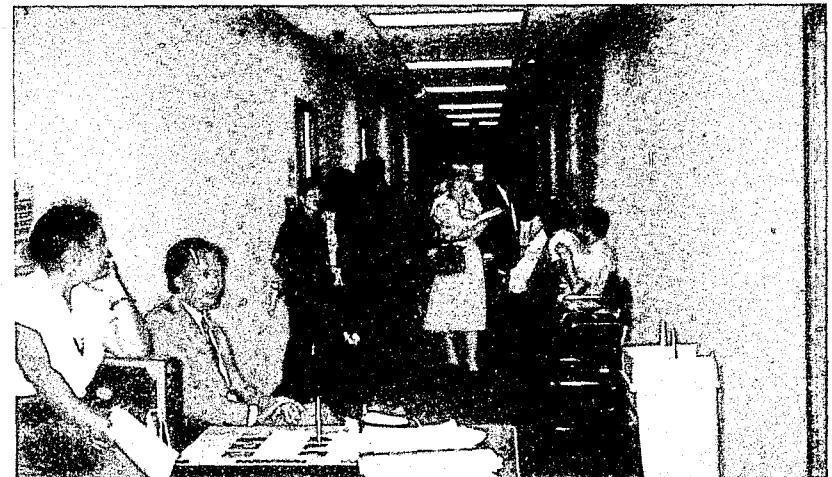
NARROW CORRIDOR LEADING TO FAMILY COURTROOMS.

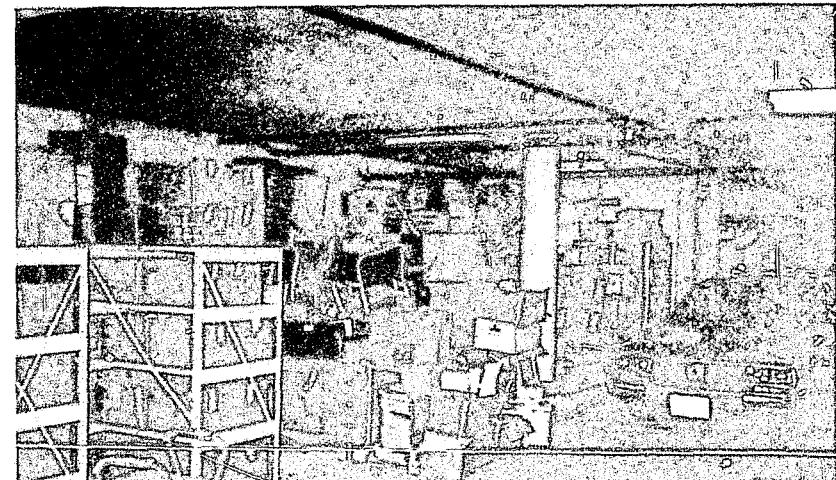
The high volume of cases tried in Family Court, together with a lack of sufficient future courtrooms to hear these cases, gives this facility an inadequate rating. Additionally, the courthouse has already filled up its storage space and is presently storing active files in an unsecured section of the parking garage.

UNSECURED ACTIVE FILES IN EMPLOYEE PARKING GARAGE.

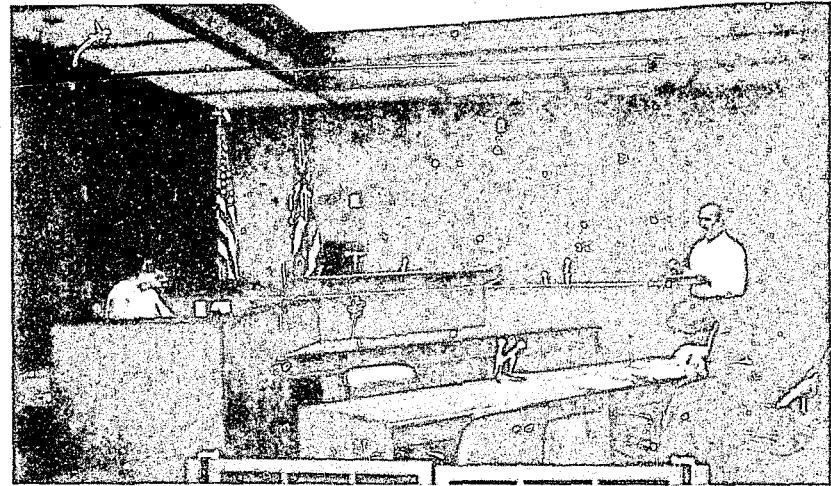
VIEW OF SMALL COURTROOM USED AS A JURY DELIBERATION ROOM.

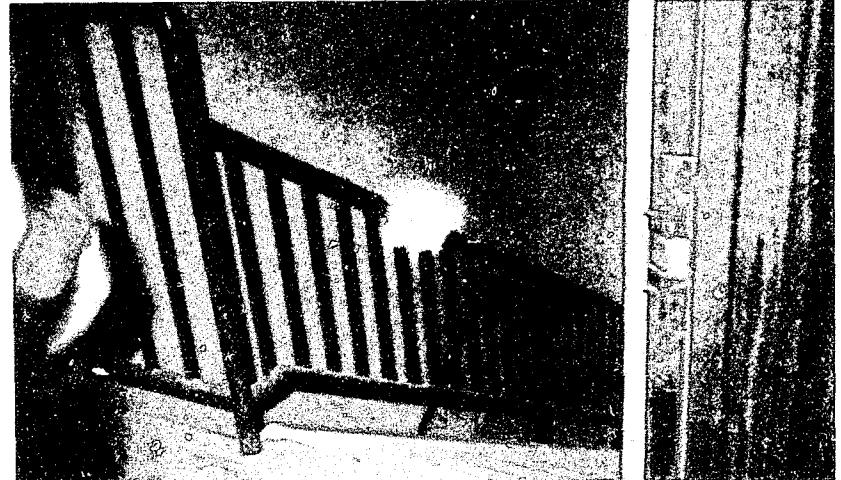
VIEW OF STAIRWAY BETWEEN COURTROOMS WHICH SERVES FLOORS SIX TO TEN. THIS STAIRWAY MAY BE MISTAKEN AS A FIRE EXIT DURING AN EMERGENCY.

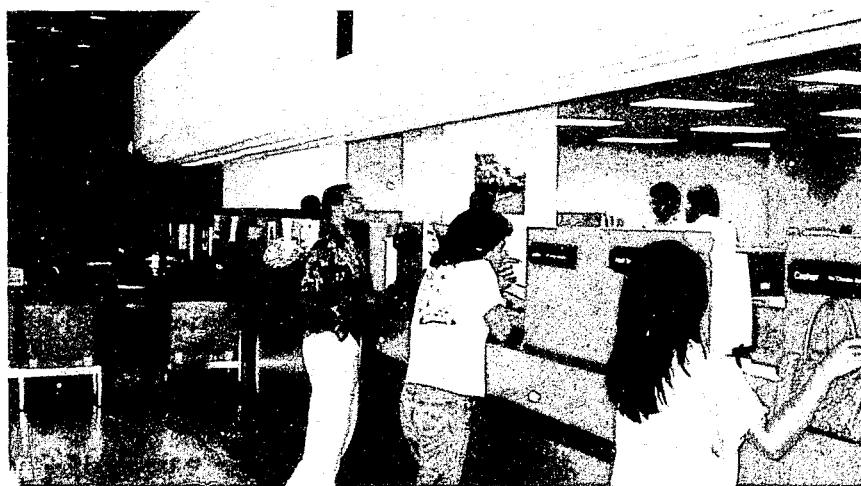
VIEW OF CLERK'S COUNTER.

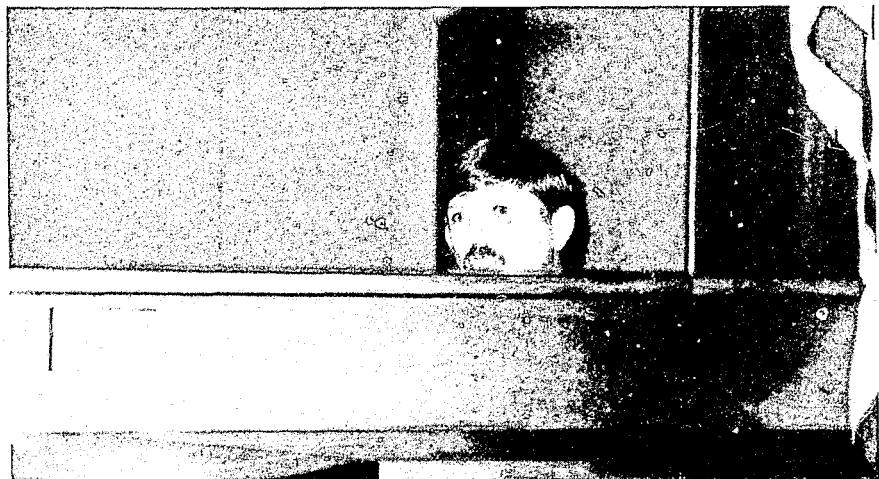
HIGH DIVIDER AT THE WITNESS BOX RESTRICTS THE VIEW FOR A JUROR AT THE LOWEST LEVEL.

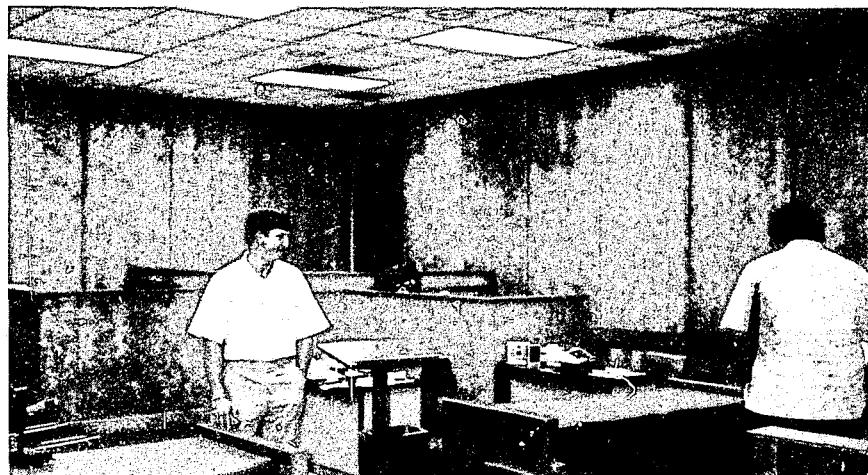
VIEW OF CIRCUIT COURTROOM SHOWING JUDGE'S BENCH IN THE CORNER.

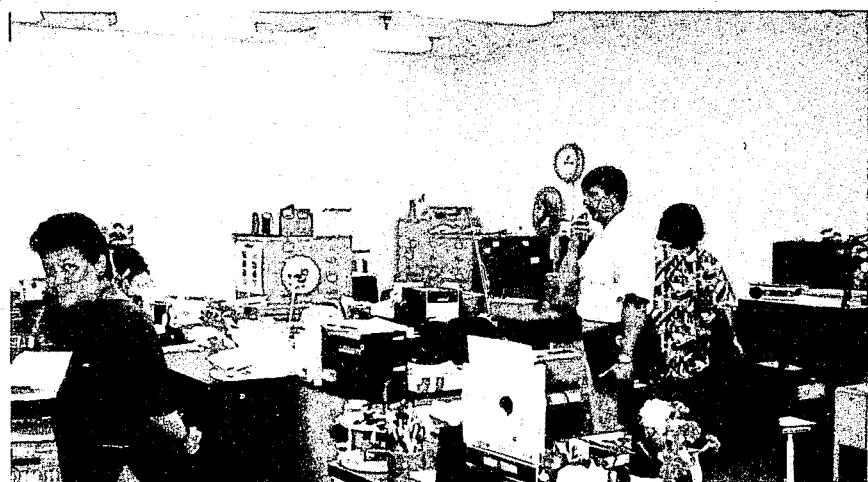
VIEW OF CLERK'S OFFICE.

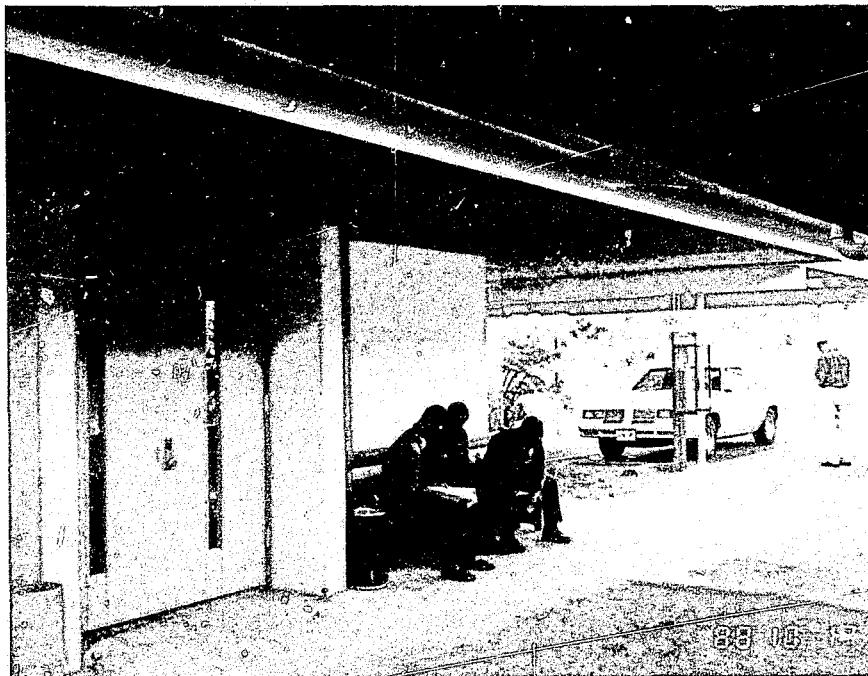
COVERED LANAI BETWEEN COURTHOUSE AND POLICE STATION SHOWING ATTORNEY CONFERRING WITH CLIENT.

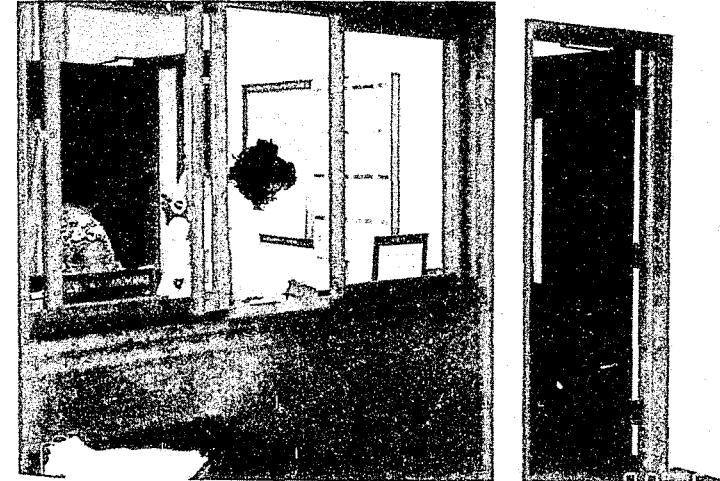
VIEW OF PUBLIC LOBBY AT CLERK'S COUNTER.

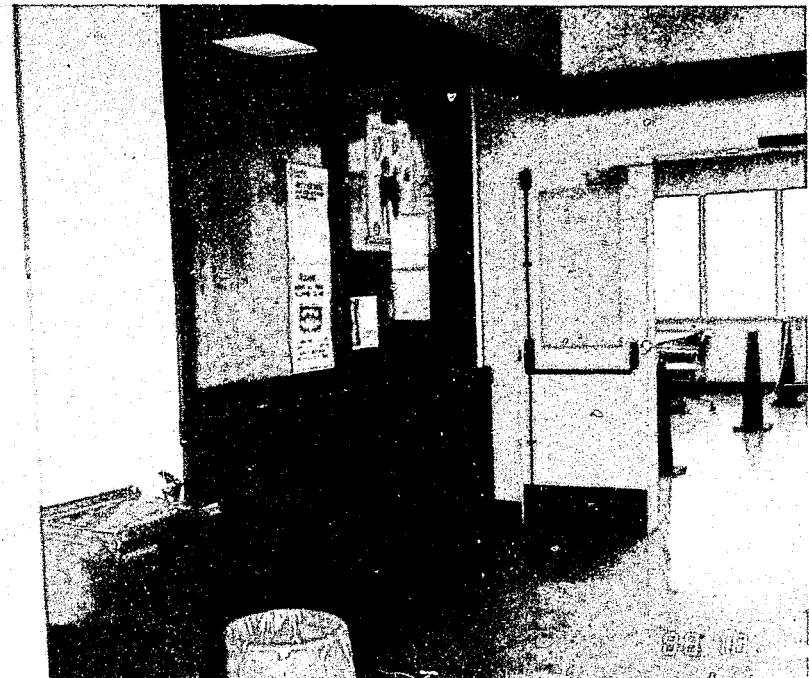
LOBBY LOOKING TOWARDS ENTRANCE TO COURTROOM AND CLERK'S COUNTER.

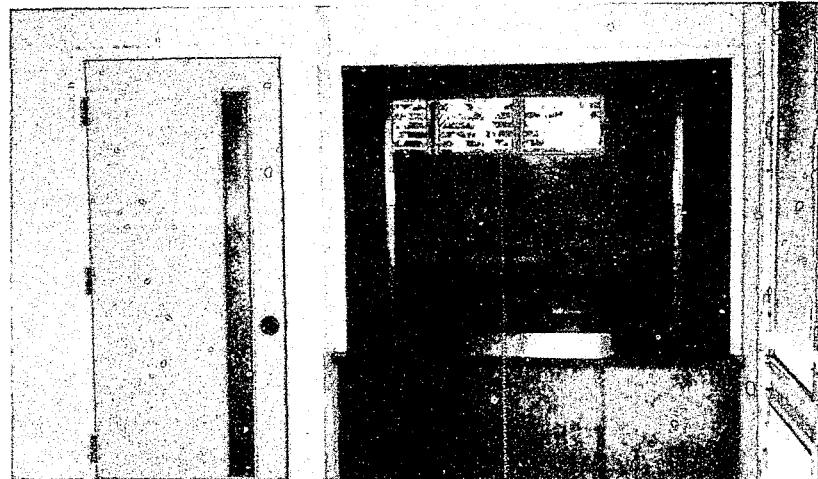
LOBBY/WAITING AREA FOR COURTROOM AND CLERK'S COUNTER.

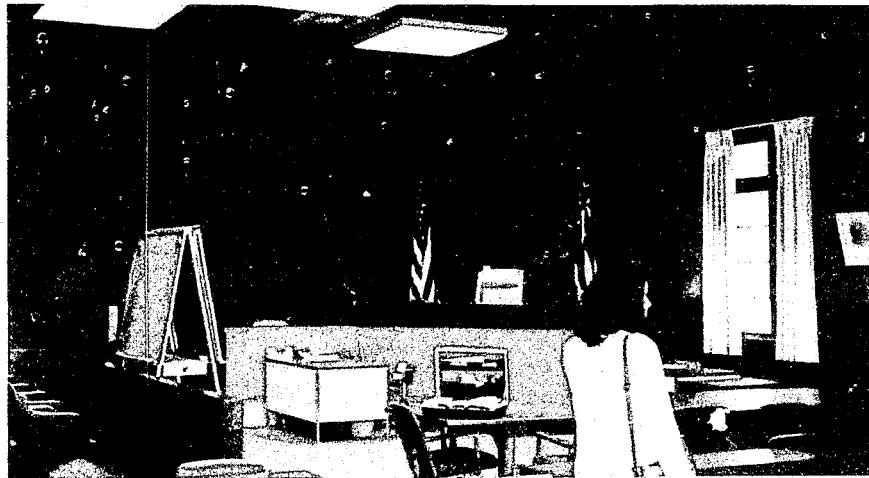
VIEW OF CIRCUIT COURTROOM.

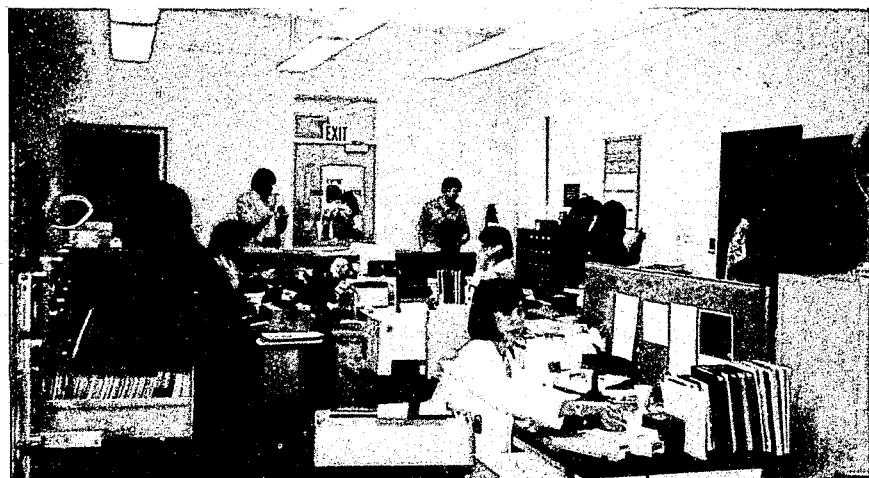
VIEW OF CLERK'S OFFICE.

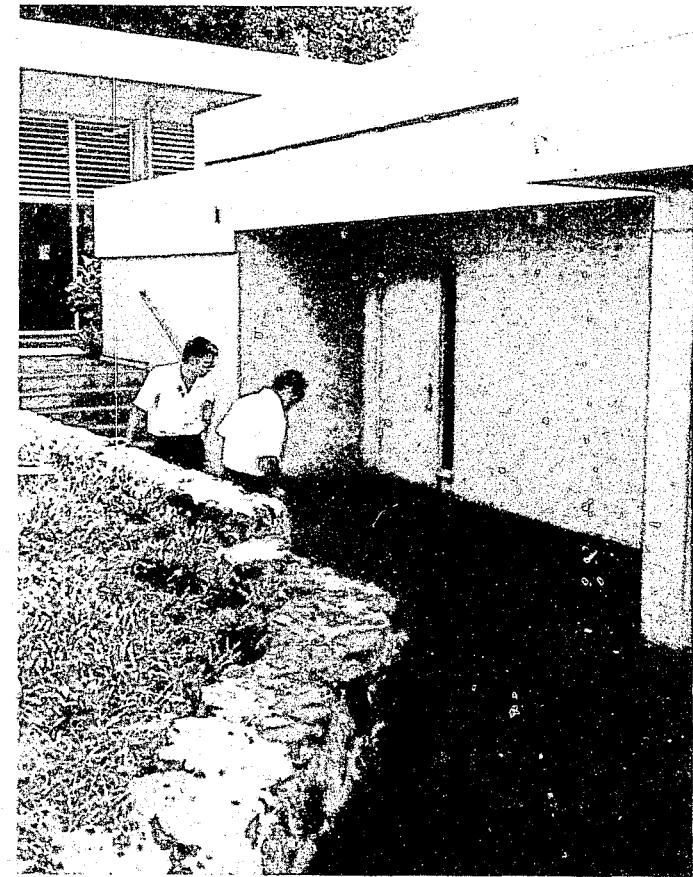
With a slightly increasing volume of usage, this Courthouse is considered marginal operationally. The Courthouse lacks waiting/seating area for the general public. Entrance to the courtroom is directly from the outside which causes a noise problem. Without any holding cells, detainees are seated with the public until they are brought to the litigation area.

DOOR ENTERING DIRECTLY INTO COURTROOM.

Given the relatively low volume of use, this facility is considered generally adequate; however, an enclosed vestibule is suggested at the entry into the courtroom to mitigate noise. It is also recommended that additional waterproofing be provided to the exterior walls enclosing the courtroom.
